BUILDING 105

Historic Structure Report

FINAL
May 2015

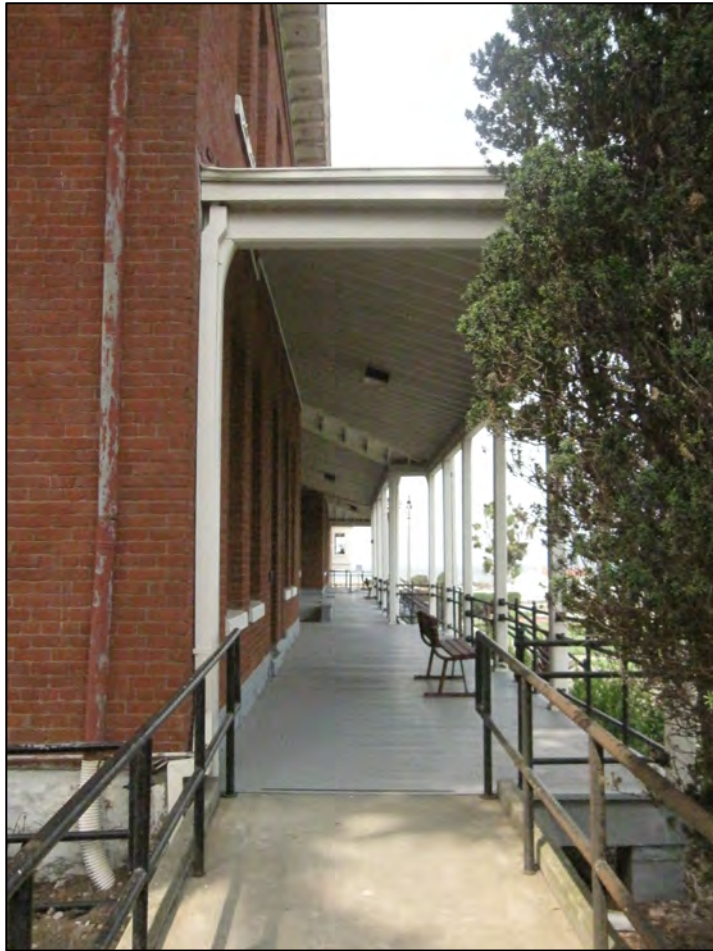
A detail of the front veranda stairs and railings. Note the replacement stair railings are heftier than the original railings which remain at the veranda.

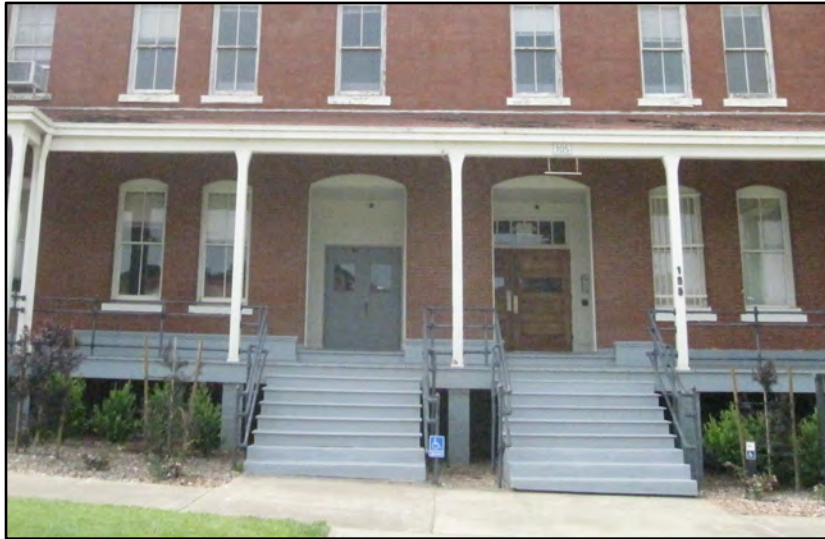
Above: The double doors of the “Two Barracks” configuration. The outermost door that created a small vestibule has been removed. The location of the inner doors has become the exterior door location. The doors are replacements.

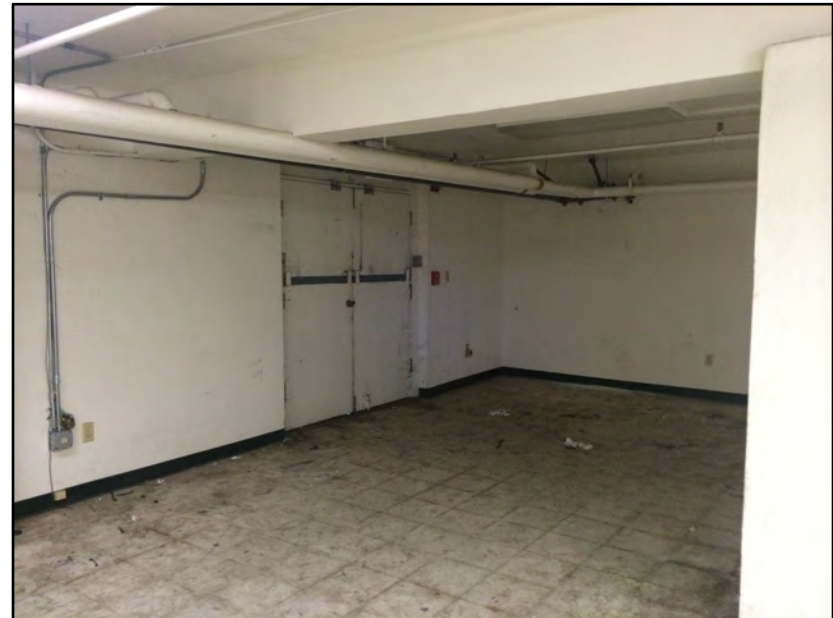
Typical basement room with very little historic fabric remaining.

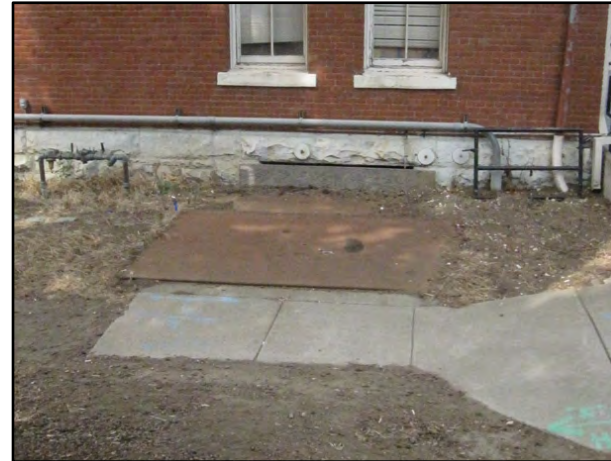
Weeds and dirt are piled against the stone foundation in places and where stairwells and doors were once located there are metal or wood barriers.

Above Right: Covered basement door at the east end of the south elevation

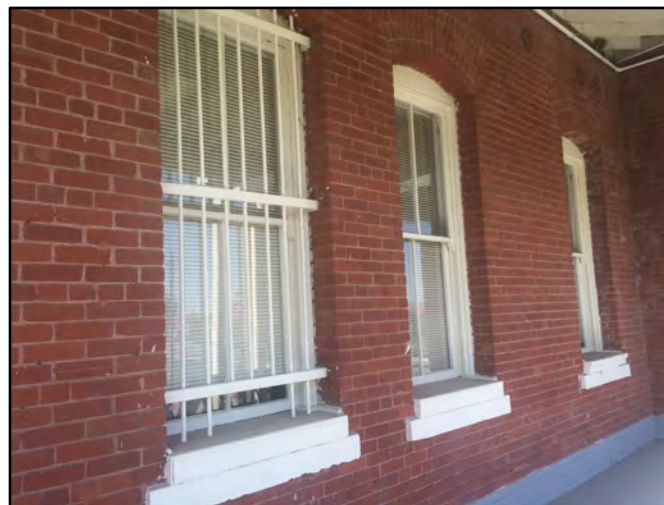
The windows at the first and second story of the building are cut and tooled sandstone lug sills. These features are in varying states of repair. All were painted at one point and the paint is not adhering well to the stone. There are three windows that face the east veranda that have a secondary sill applied over the stone sill. This is the only location where this occurs.

Above: The three windows that face the east veranda with the secondary wood sill.

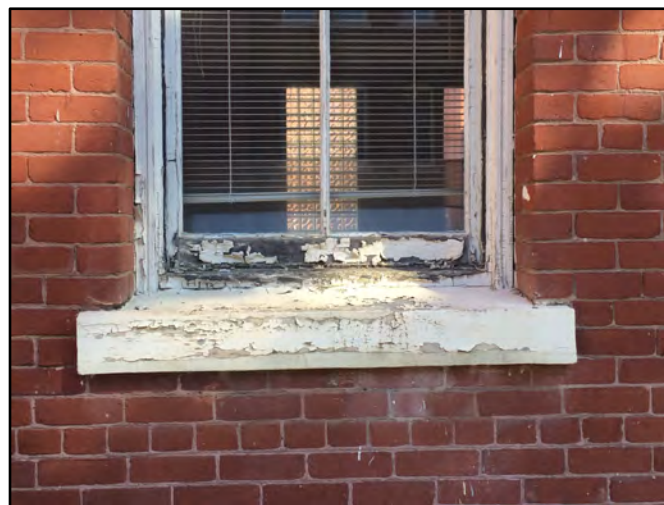
Below: Typical peeling paint conditions at both the sill and the wood window along the north and south wings.

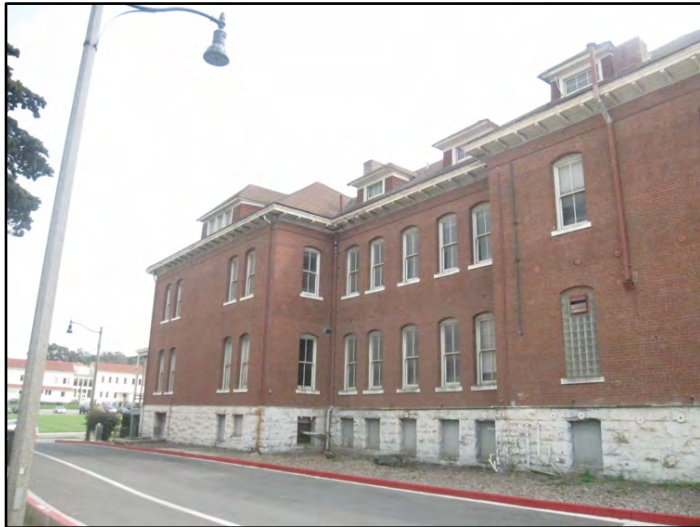
The basement windows are formed from punched openings in the concrete and sandstone foundation walls. For security purposes, these windows have been boarded at the exterior and interior and the current condition is unknown. It is thought that they were either wood casement or hopper windows.

The punched openings of the basement windows along the north elevation. Note the boards covering the windows as a security protection measure. This occurs in all basement window locations.

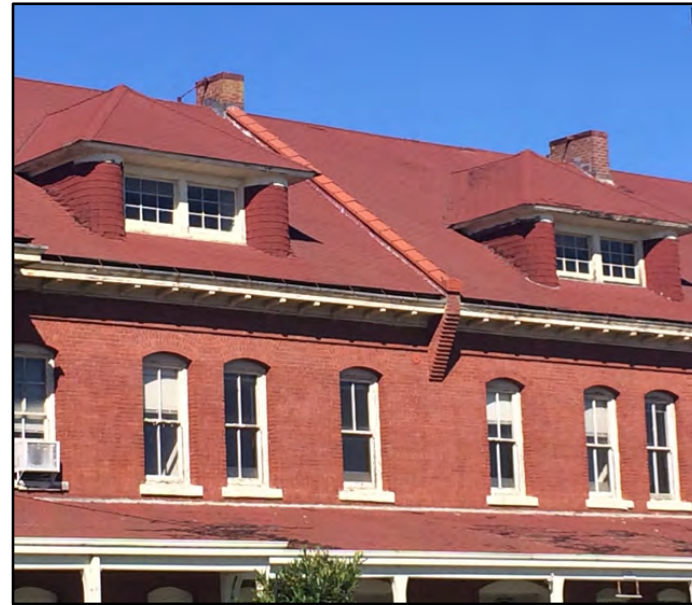
The wood double casement attic windows that sit within the dormers are in fairly good condition. The dormers in the wings There are locations where glass panes are broken or where the casements are off their hinge.

The dormer windows at the front elevation are in fairly good condition.

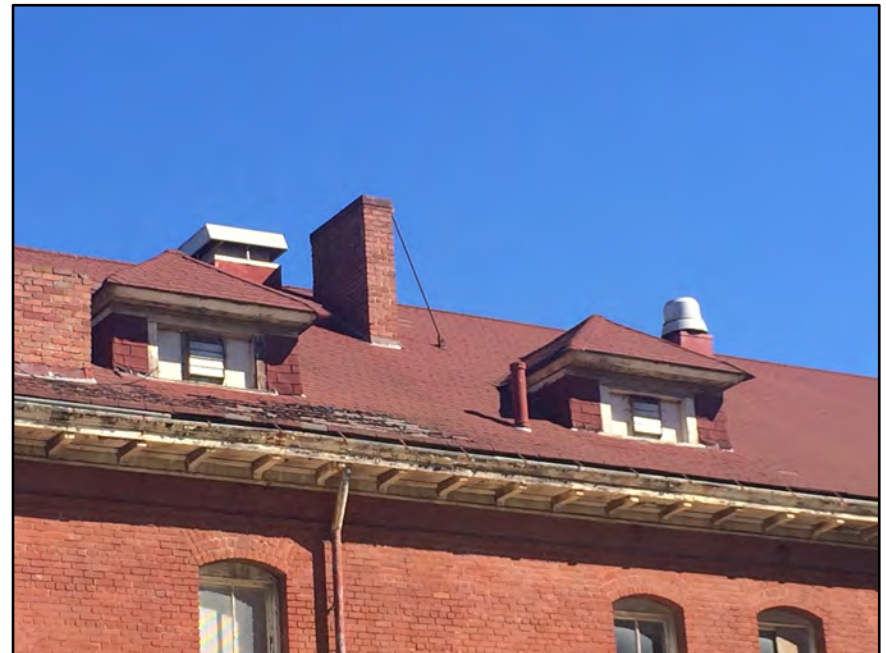
*The brick chimneys have been reduced in height, capped, strapped and
braced.*

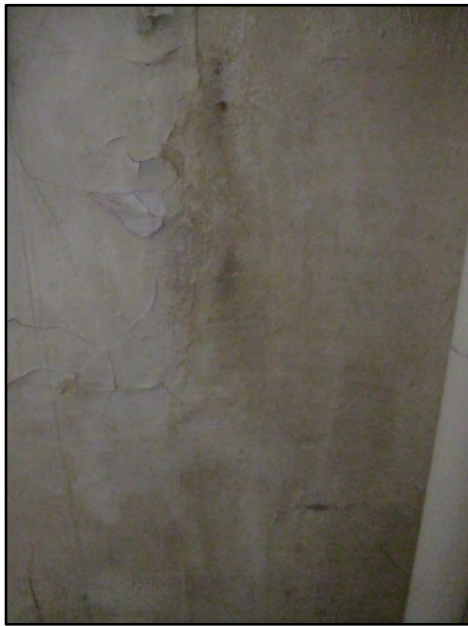
Plaster damage near stair 104
