### REUSE ANALYSIS POST EXCHANGE AND COMMISSARY

### TECHNICAL MEMORANDUM

28 DECEMBER 2001

subject	Reuse Analysis Memoranda		
contract/task no.	PT-2000-010/TX015142		
project no.	14017.00		
project name	Reuse Analysis of PX and Commissary		
from	Sasaki Associates Inc.		
to	The Presidio Trust		
date	28 December 2001

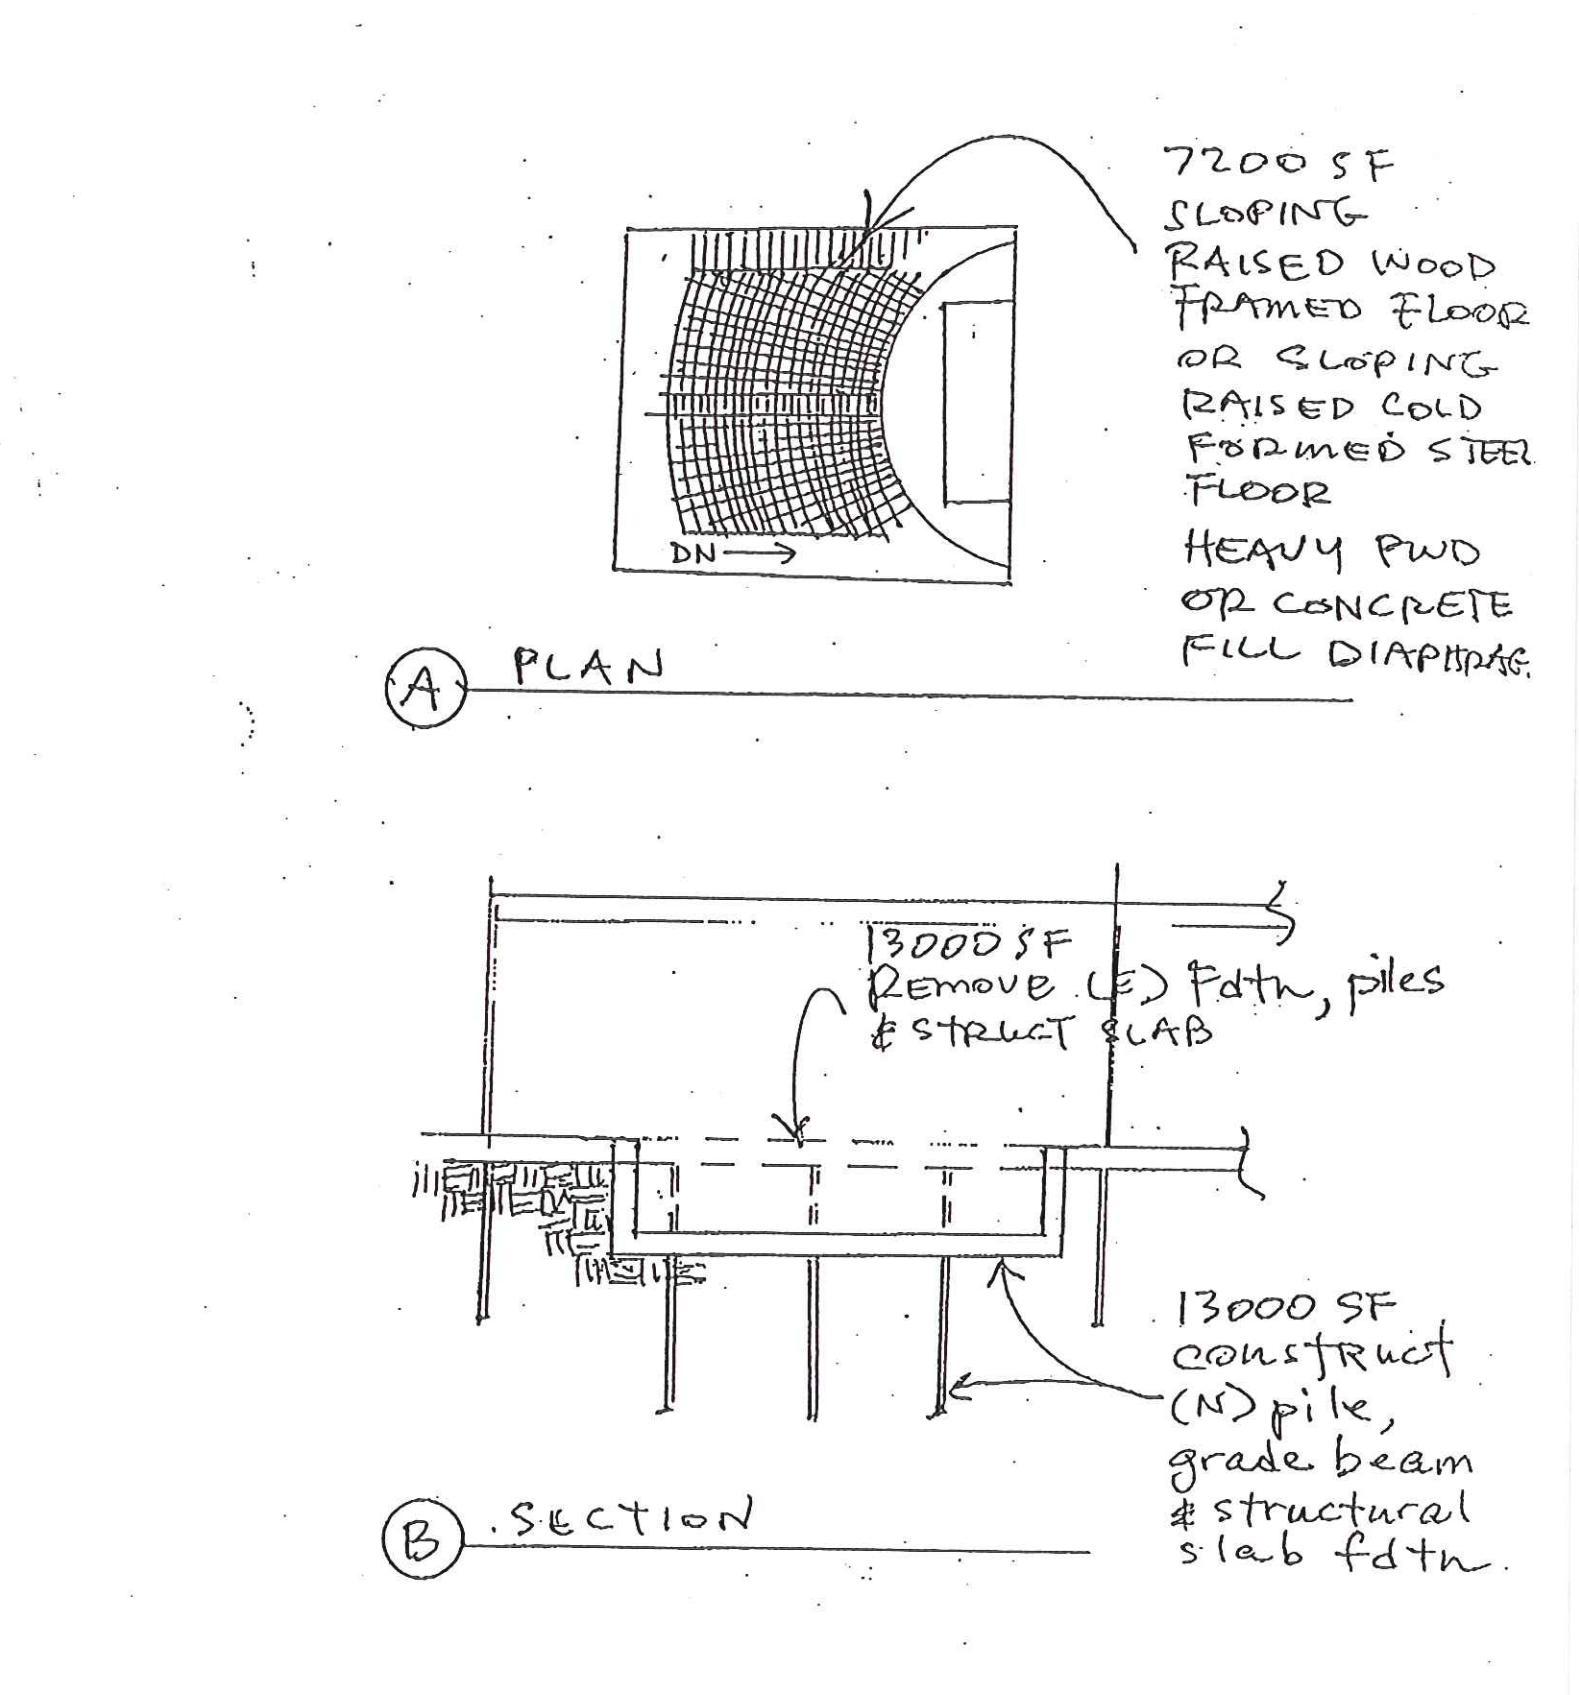
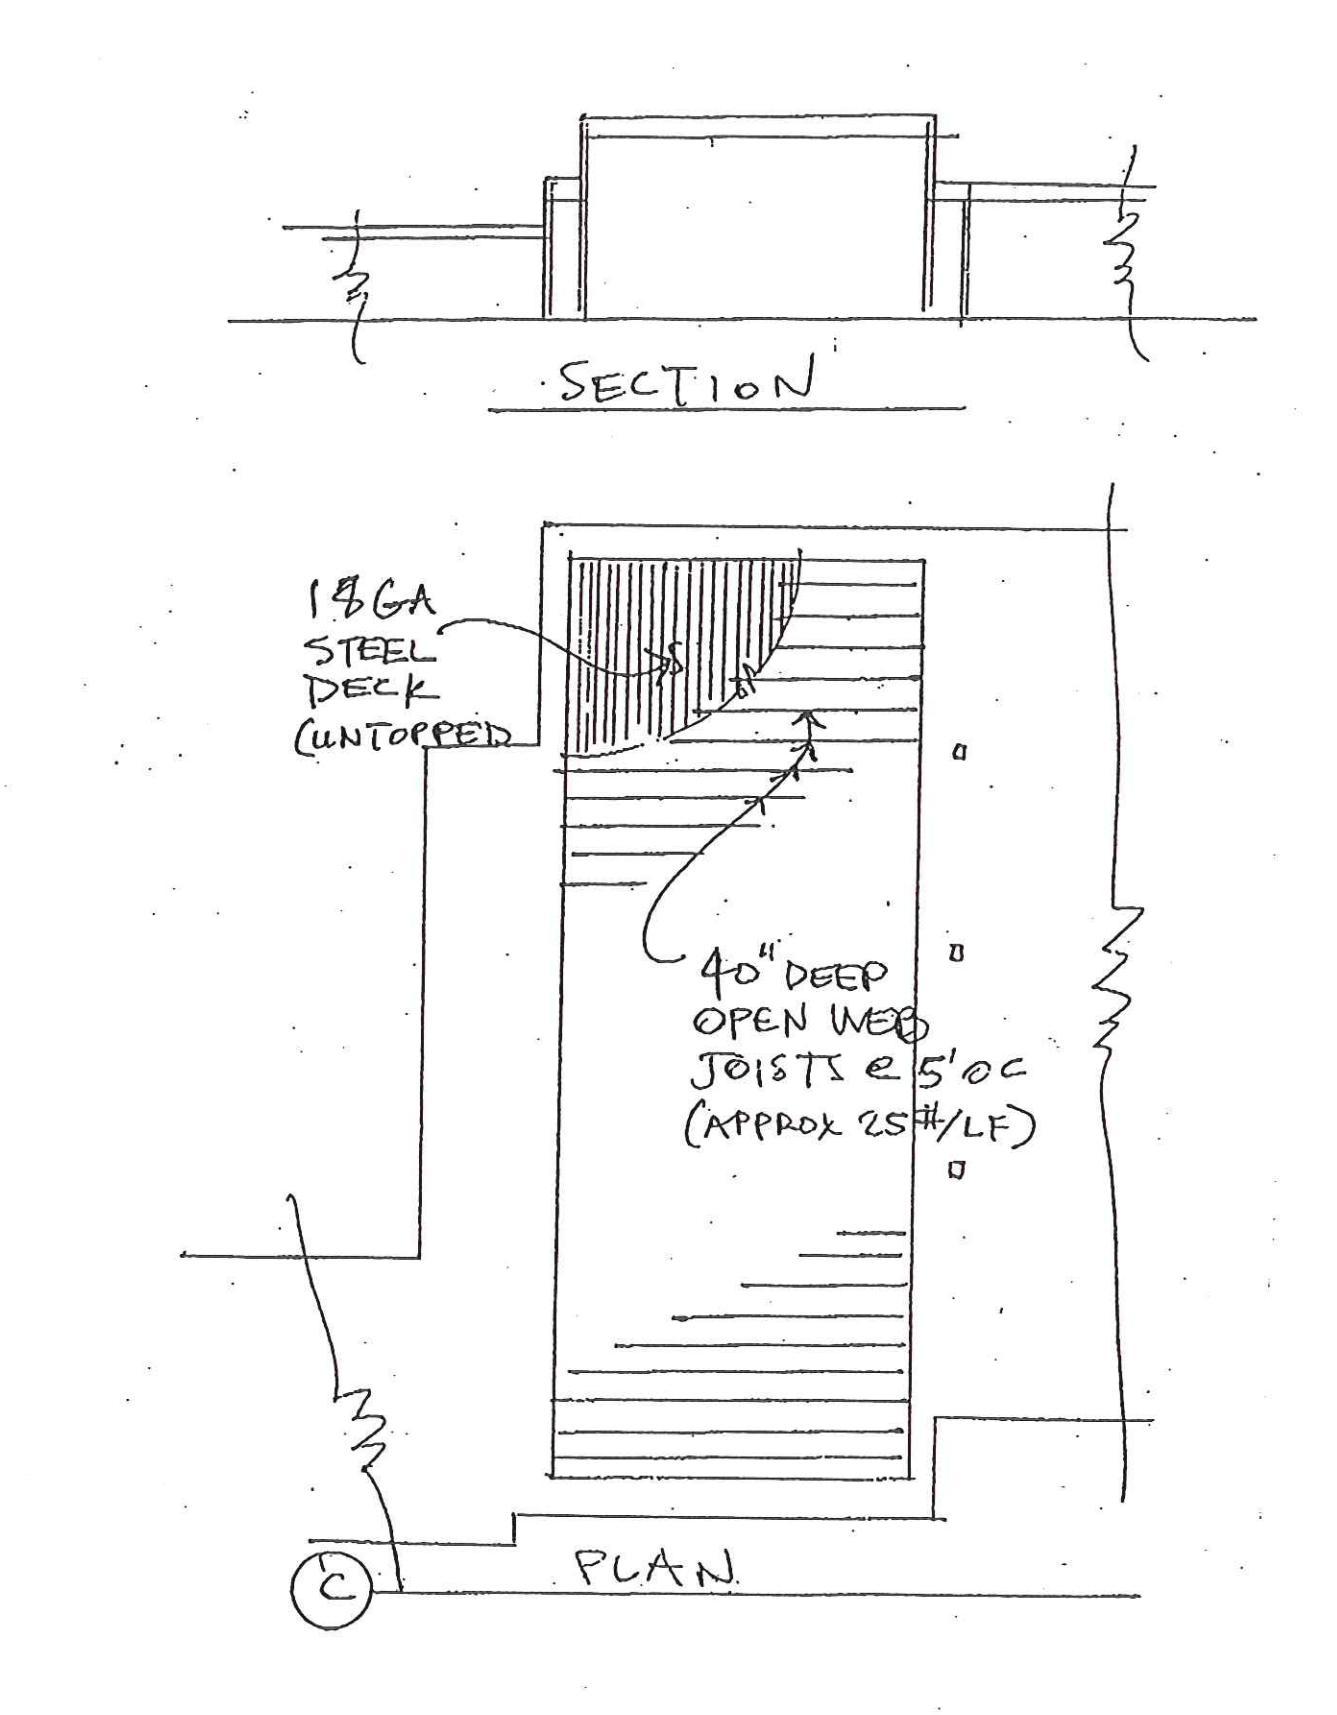
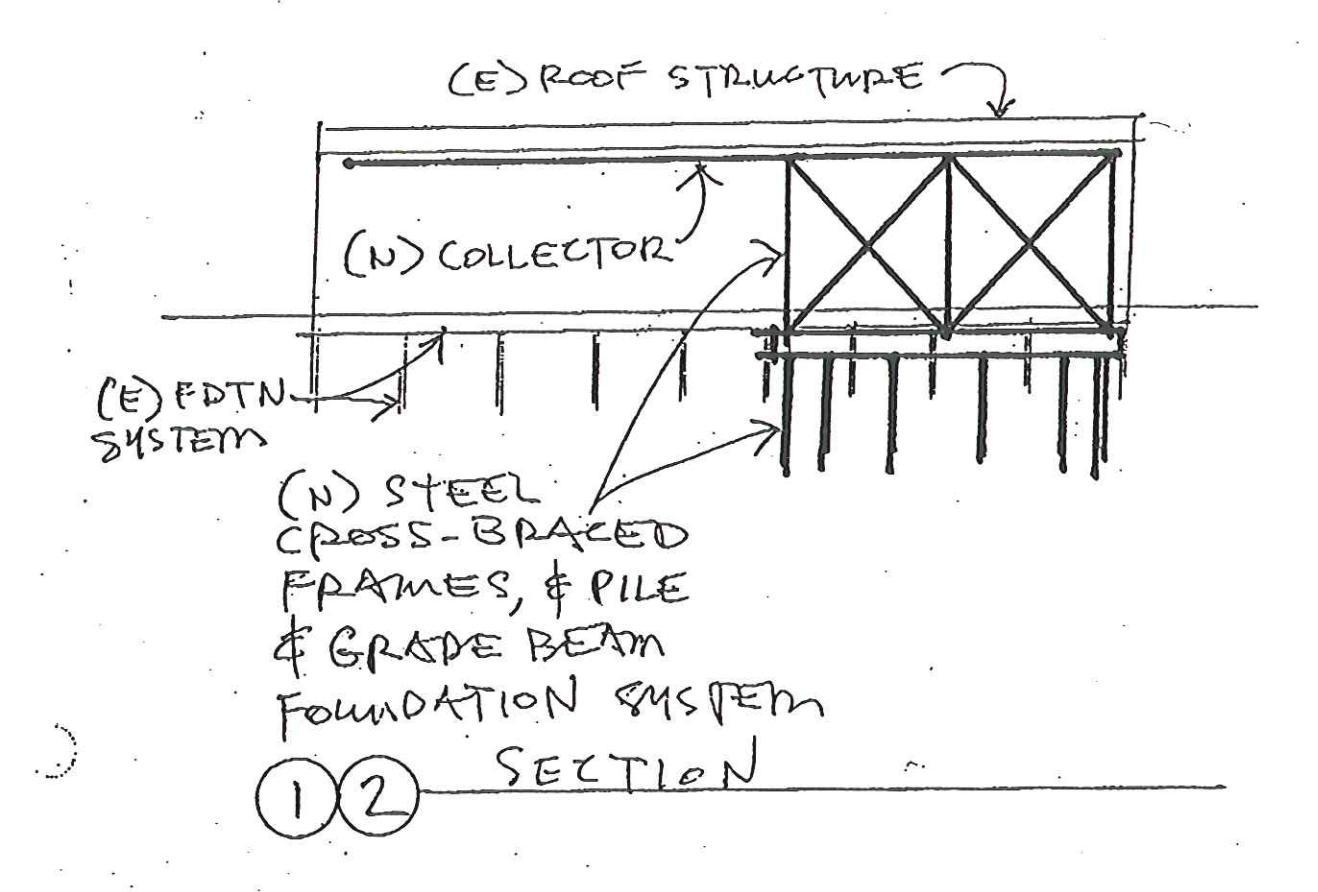
### **POST EXCHANGE - STRUCTURAL MODIFICATIONS**

Configurational Dessible sloped floor @ Theater Seismic DAdd braced frames w/fdths - 2 Add Collectors

By constructing braced frames in each direction of each building portion, all suspected structural deficiencies (except the building gap issue) could be mitigated. It is assumed that the building gap issue can be tolerated.

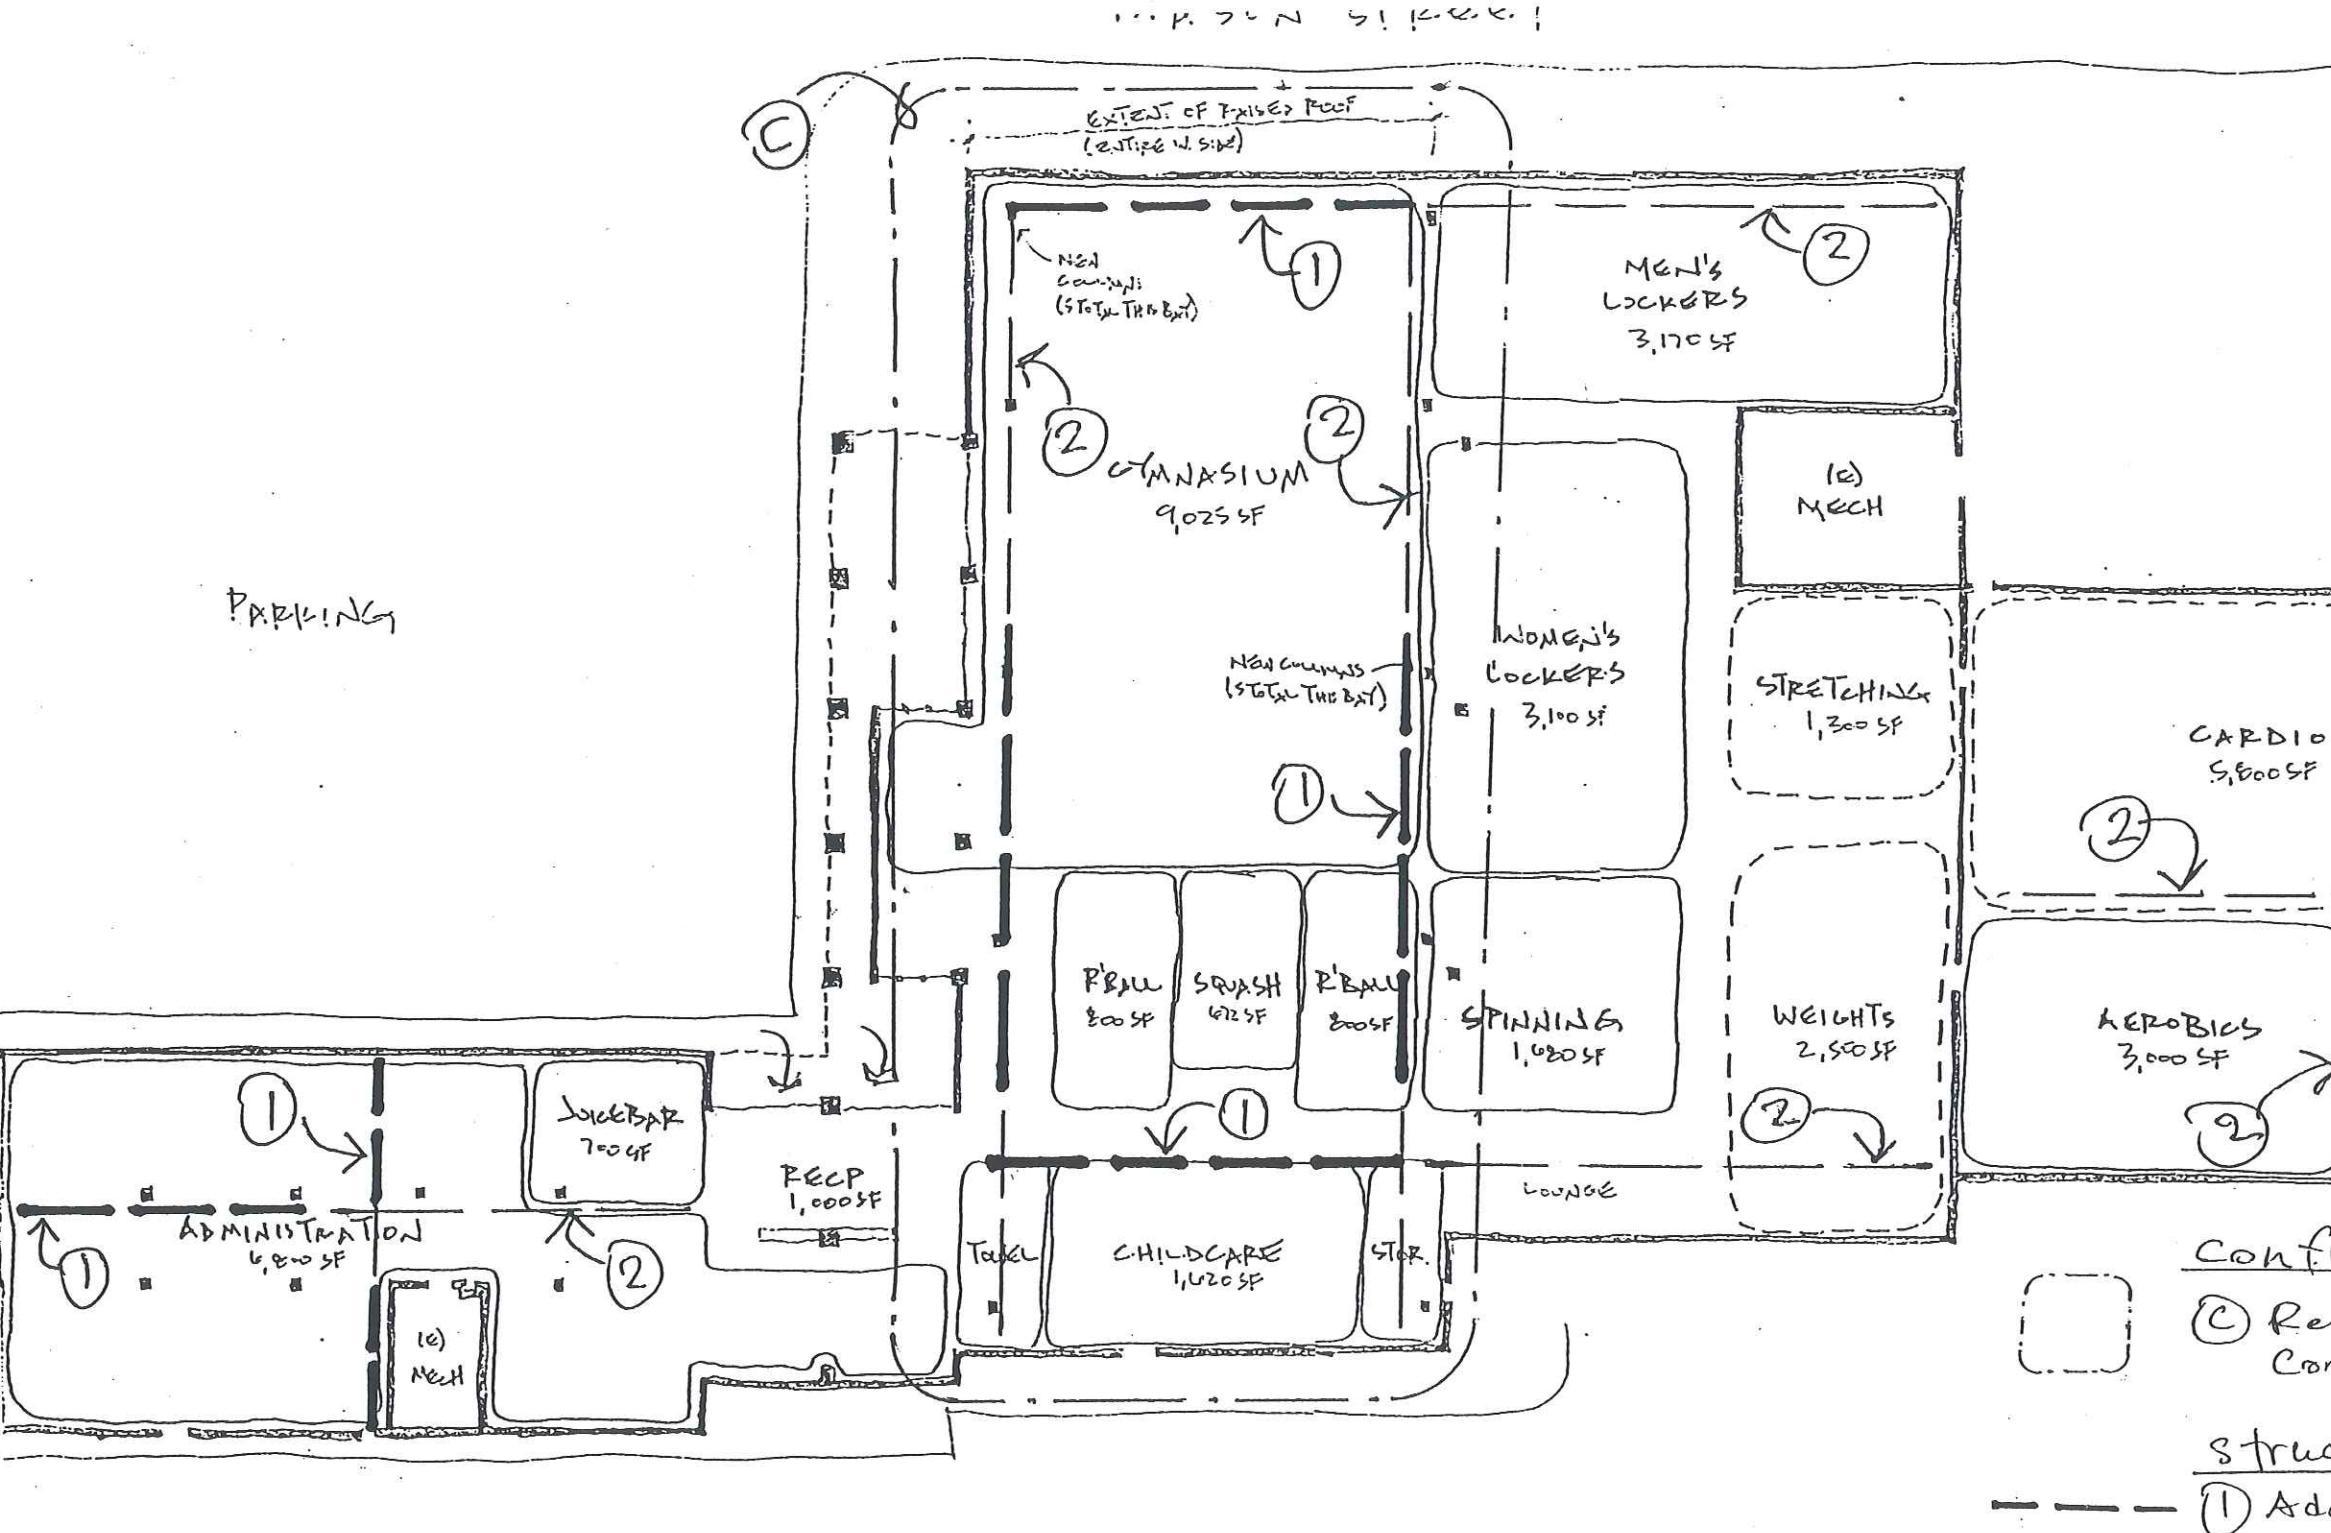
# POST EXCHANGE - RECREATION/GYMNASIUM ALTERNATIVE - STRUCTURAL MODIFICATIONS

wear were and and a state was a state where we have a CRISS-( FIELD CENTER AEROBICS 2,250 SF Configurational C Remove (E) roof structure Construct (N) roof structure - DAdd braced frames W/foths - DAdd collectors

By constructing braced frames in each direction of each building portion, all suspected structural deficiencies (except the building gap issue) could be mitigated. It is assumed that the building gap issue can be tolerated.

Structural work required to accommodate configuration changes associated with building reuse would include dropping the foundation system or raising the roof structure for the two recreation reuse alternatives, either a pool area or gymnasium.
