Subject: Construction Completion Report – Vapor Mitigation System
Building 127B Riley Avenue
Section BR11-1 Fuel Distribution System
Riley Avenue, Presidio of San Francisco, San Francisco, California

Construction Completion Report
Vapor Mitigation System
Building 127B Riley Avenue
Section BR11-1
Fuel Distribution System
Riley Avenue
Presidio of San Francisco, San Francisco, California

August 30, 2019

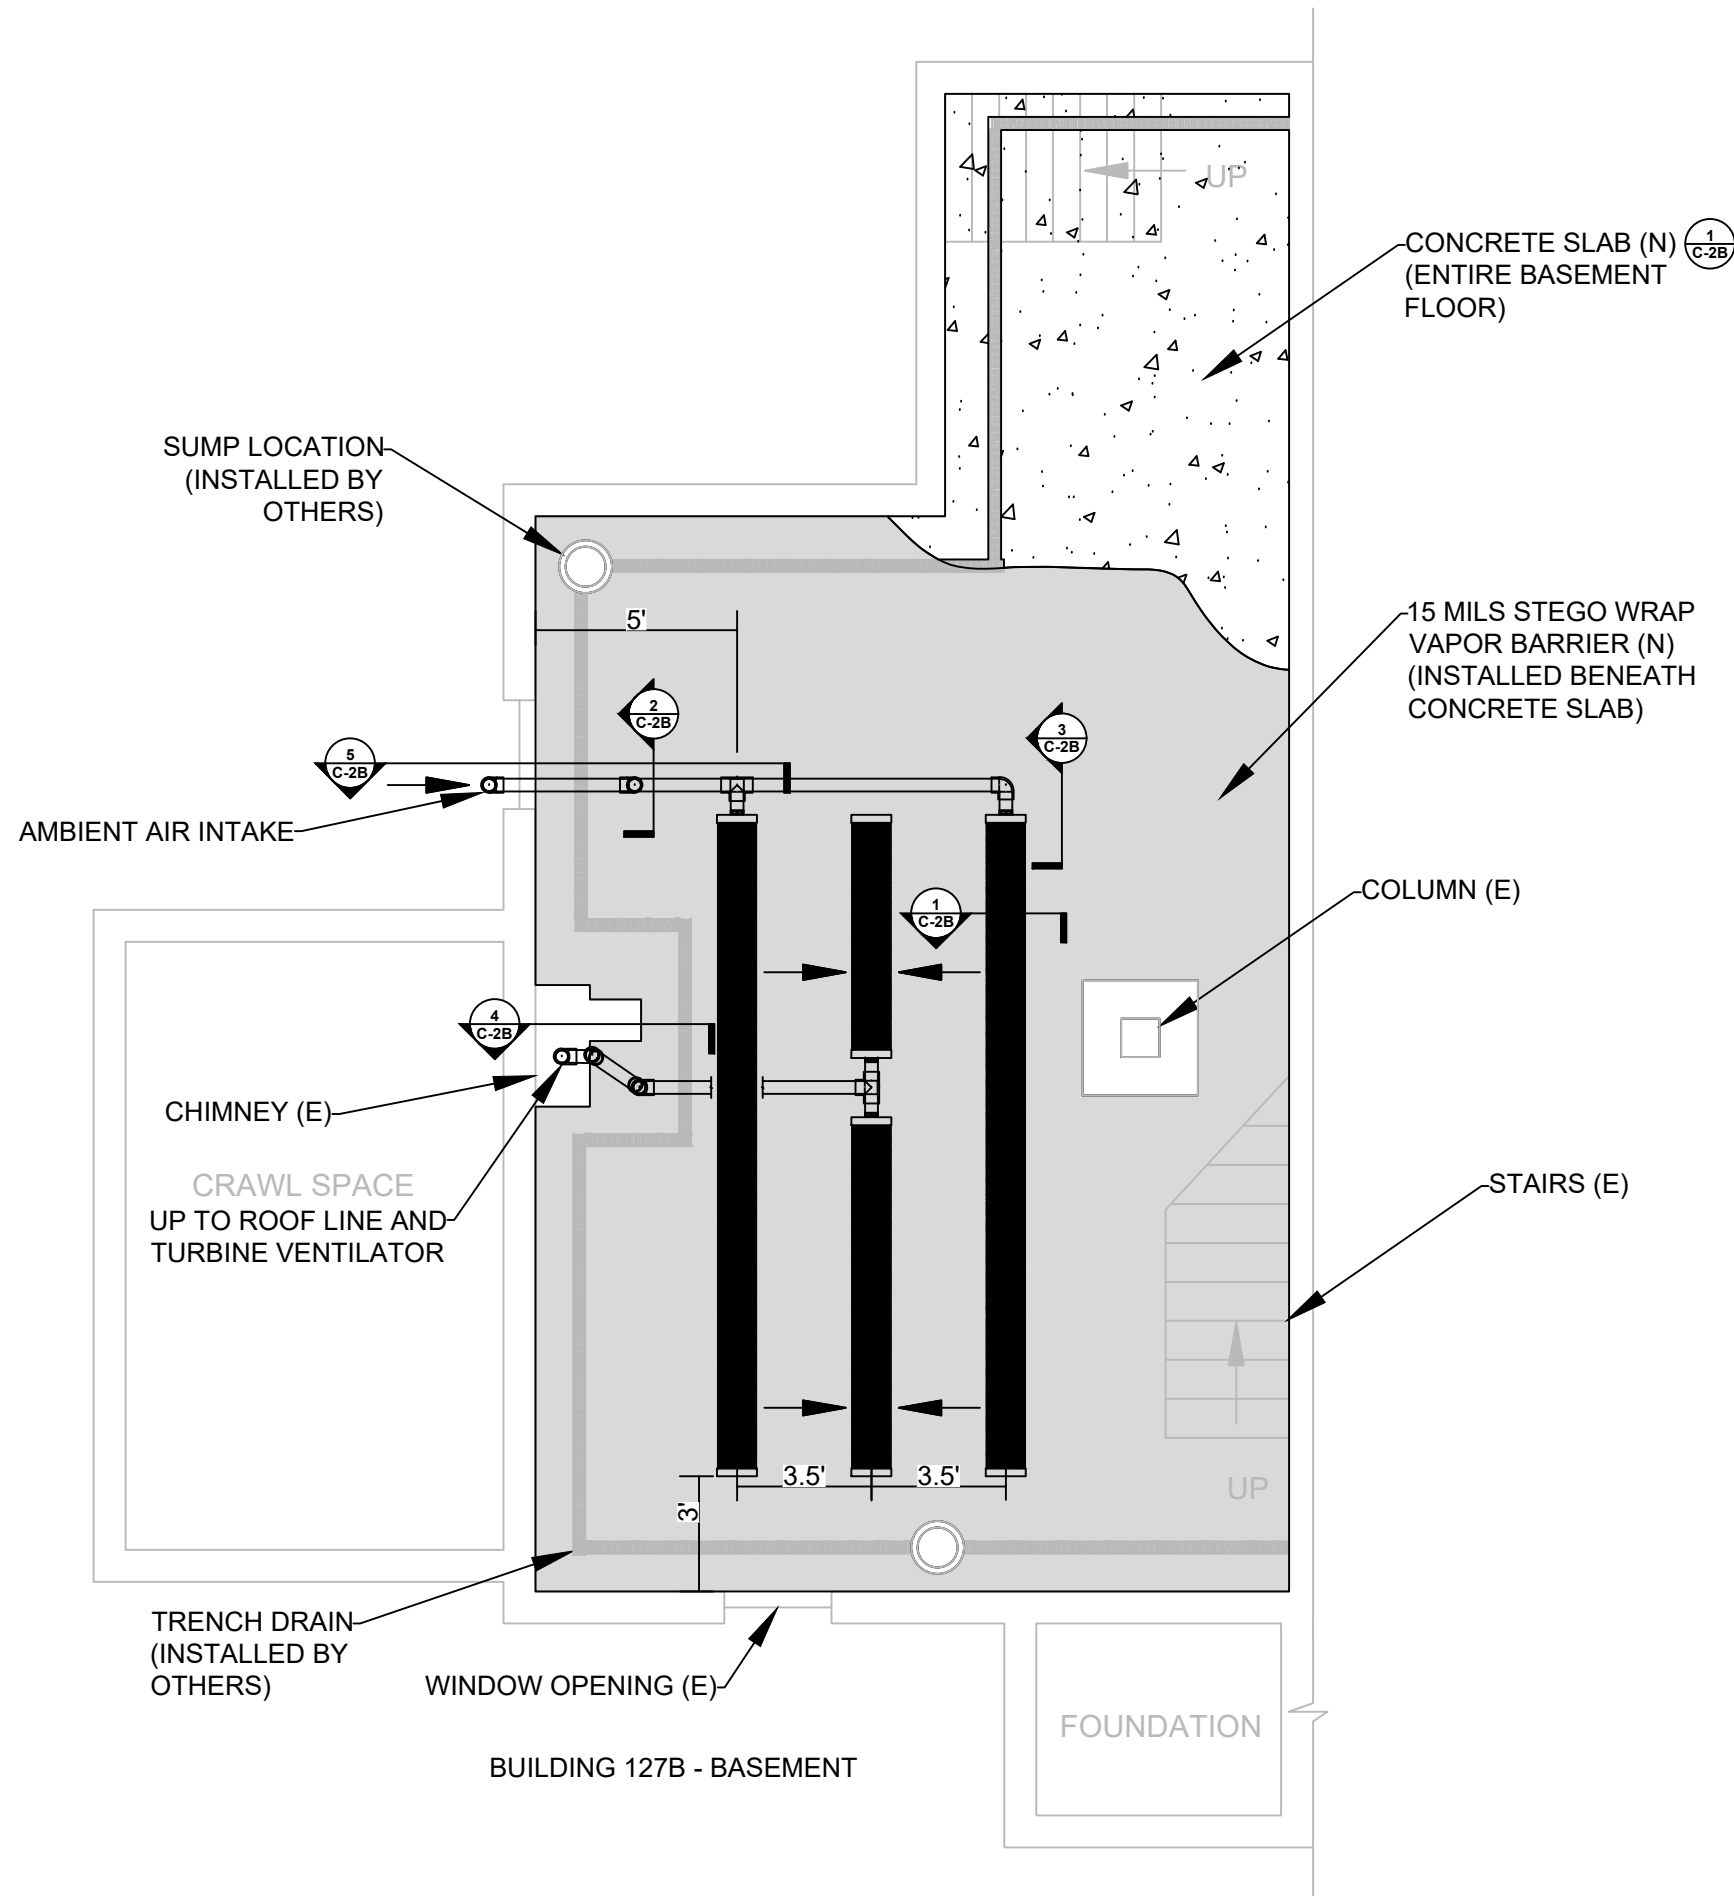
PROJECT:		THE PRESIDIO TRUST BR11-1 FUEL DISTRIBUTION SYSTEM RILEY AVENUE, SAN FRANCISCO, CALIFORNIA	
TITLE:		127B SUB-SLAB VENTING SYSTEM PLAN	
DRAWN BY:	K. LI	PROJ NO.:	285830.04A.02
CHECKED BY:	A. ANG	FIGURE 3A	
APPROVED BY:	A. ANG		
DATE:	MAY 2019

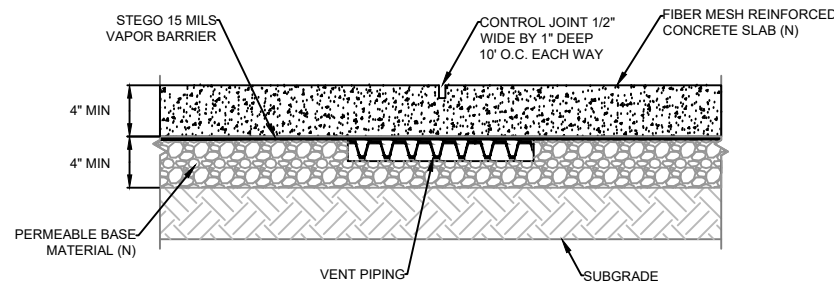
1
C-2A
TYPICAL VENT PIPE AND CONCRETE SLAB
(NOT TO SCALE)

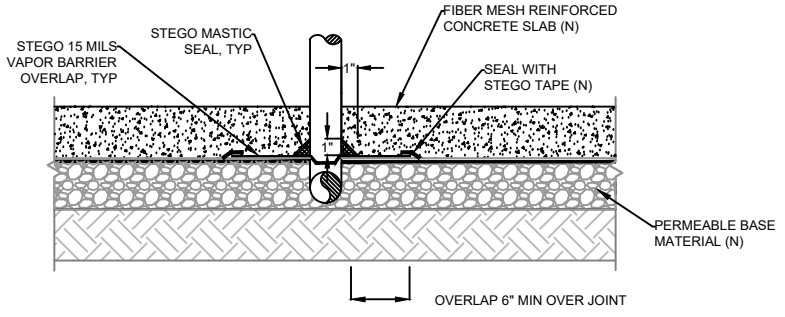
2
C-2A
TYPICAL VENT PIPE SLAB PENETRATION
(NOT TO SCALE)

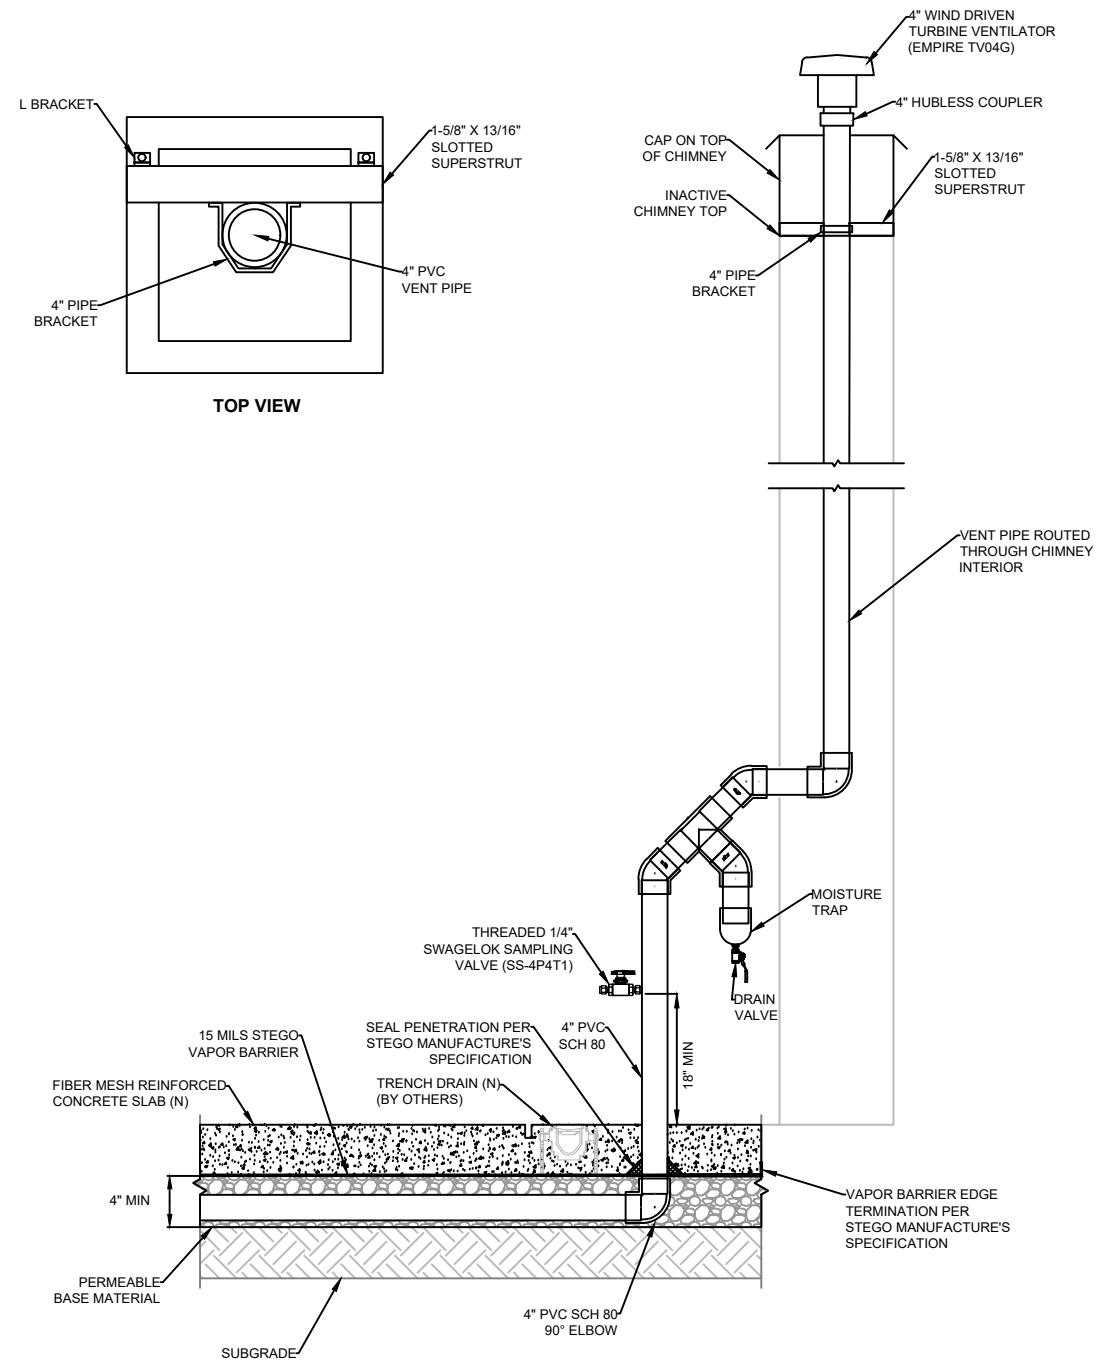
4
C-2A
VENT PIPING
(NOT TO SCALE)

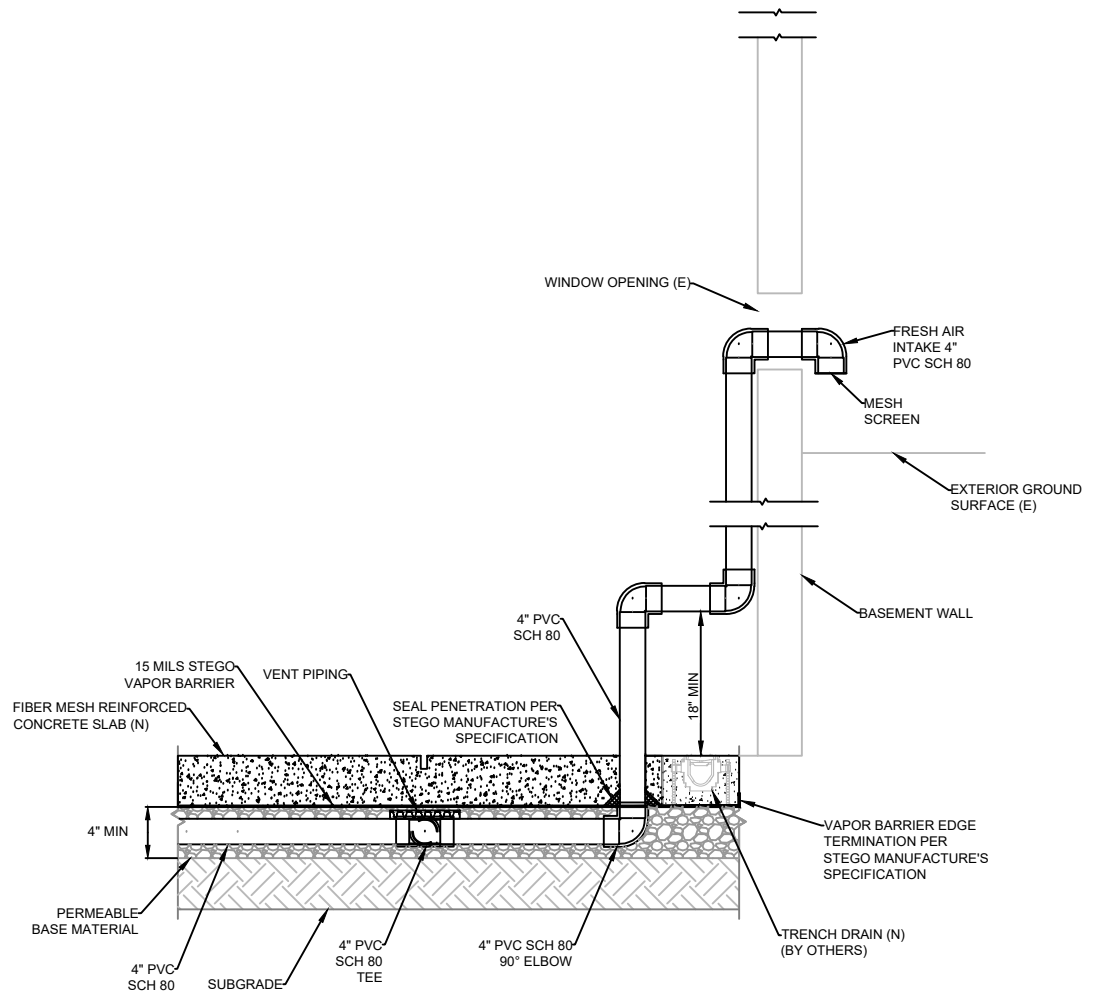
5
C-2A
AIR INTAKE PIPING
(NOT TO SCALE)

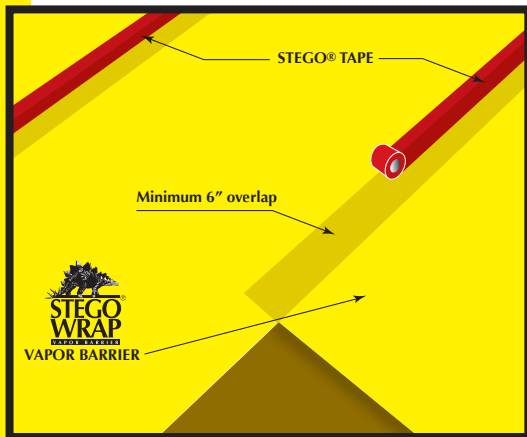
FIGURE 1: UNDER-SLAB INSTALLATION

1. Stego Wrap can be installed over an aggregate, sand, or tamped earth base. It is not necessary to have a cushion layer or sand base, as Stego Wrap is tough enough to withstand rugged construction environments.
2. Unroll Stego Wrap over the area where the slab is to be placed. Stego Wrap should completely cover the concrete placement area. All joints/seams both lateral and butt should be overlapped a minimum of six inches and taped using Stego Tape.

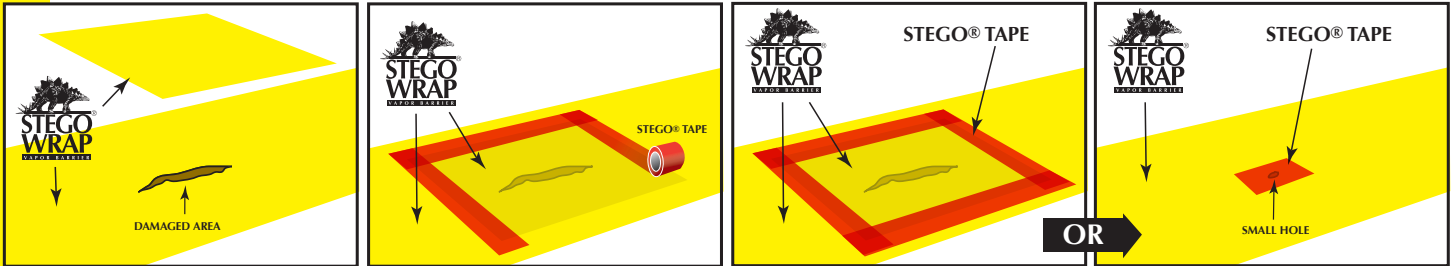
FIGURE 3: SEALING DAMAGED AREAS

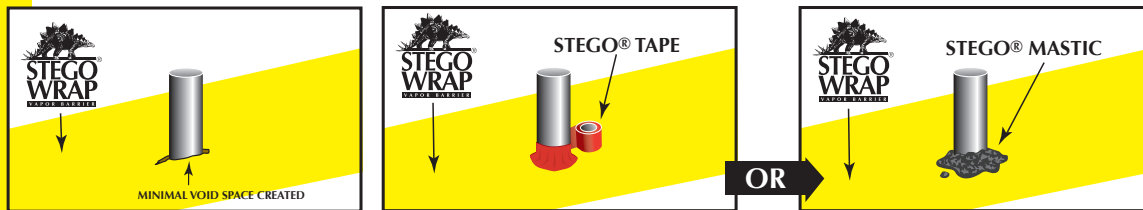
FIGURE 4a: PIPE PENETRATION SEALING

- Install Stego Wrap around pipe penetrations by slitting/cutting material as needed. Try to minimize the void space created.
- If Stego Wrap is close to pipe and void space is minimized then seal around pipe penetration with Stego Tape and/or Stego Mastic. **[See Figure 4a]**
- If detail patch is needed to minimize void space around penetration, then cut a detail patch to a size and shape that creates a six inch overlap on all edges around the void space at the base of the pipe. Stego Pre-Cut Pipe Boots are also available to speed up the installation.
- Cut an "X" the size of the pipe diameter in the center of the pipe boot and slide tightly over pipe.
- Tape down all sides of the pipe boot with Stego Tape.
- Seal around the base of the pipe using Stego Tape and/or Stego Mastic. **[See Figure 4b]**

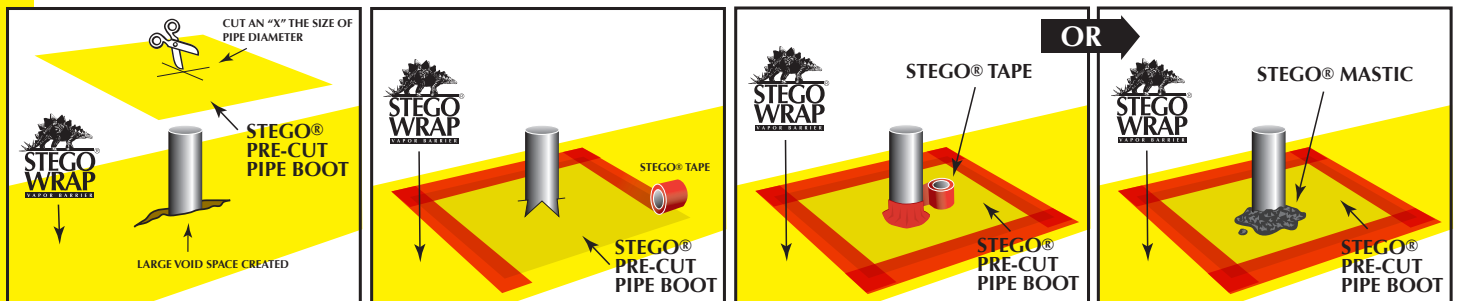
FIGURE 4b: DETAIL PATCH FOR PIPE PENETRATION SEALING

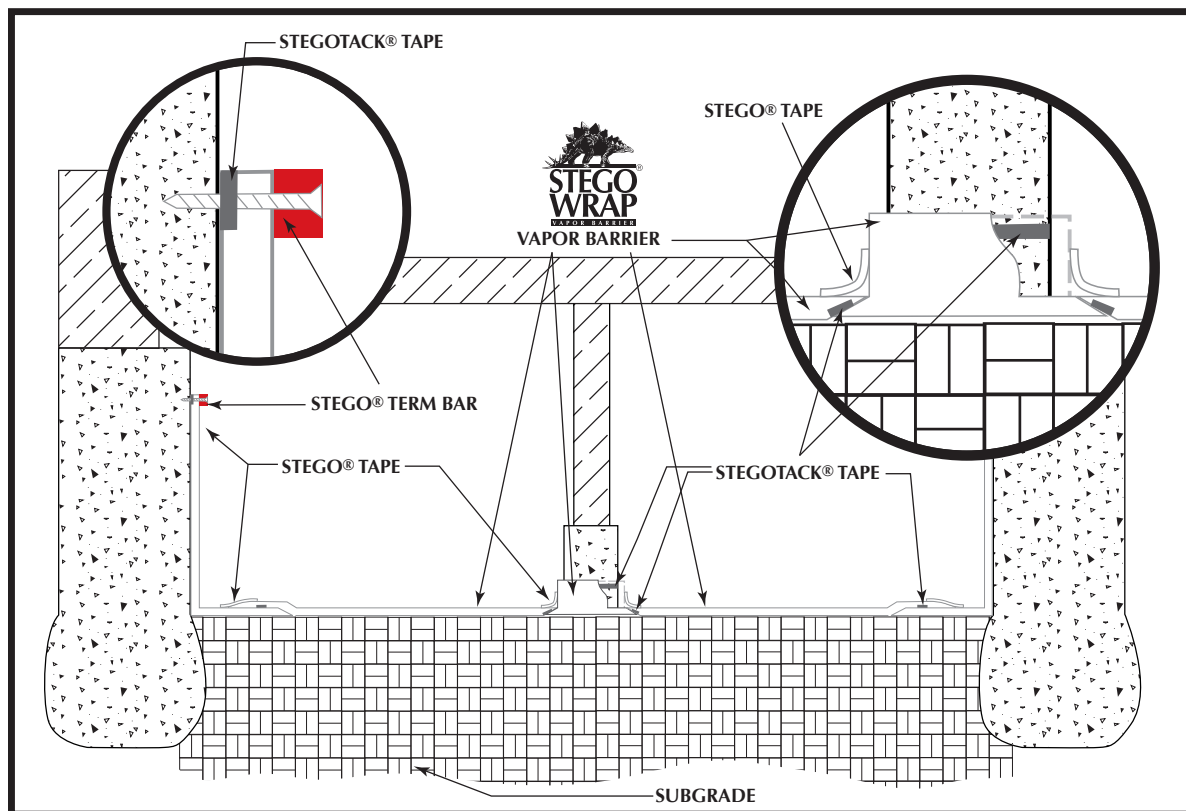
FIGURE 6: CRAWL SPACE INSTALLATION

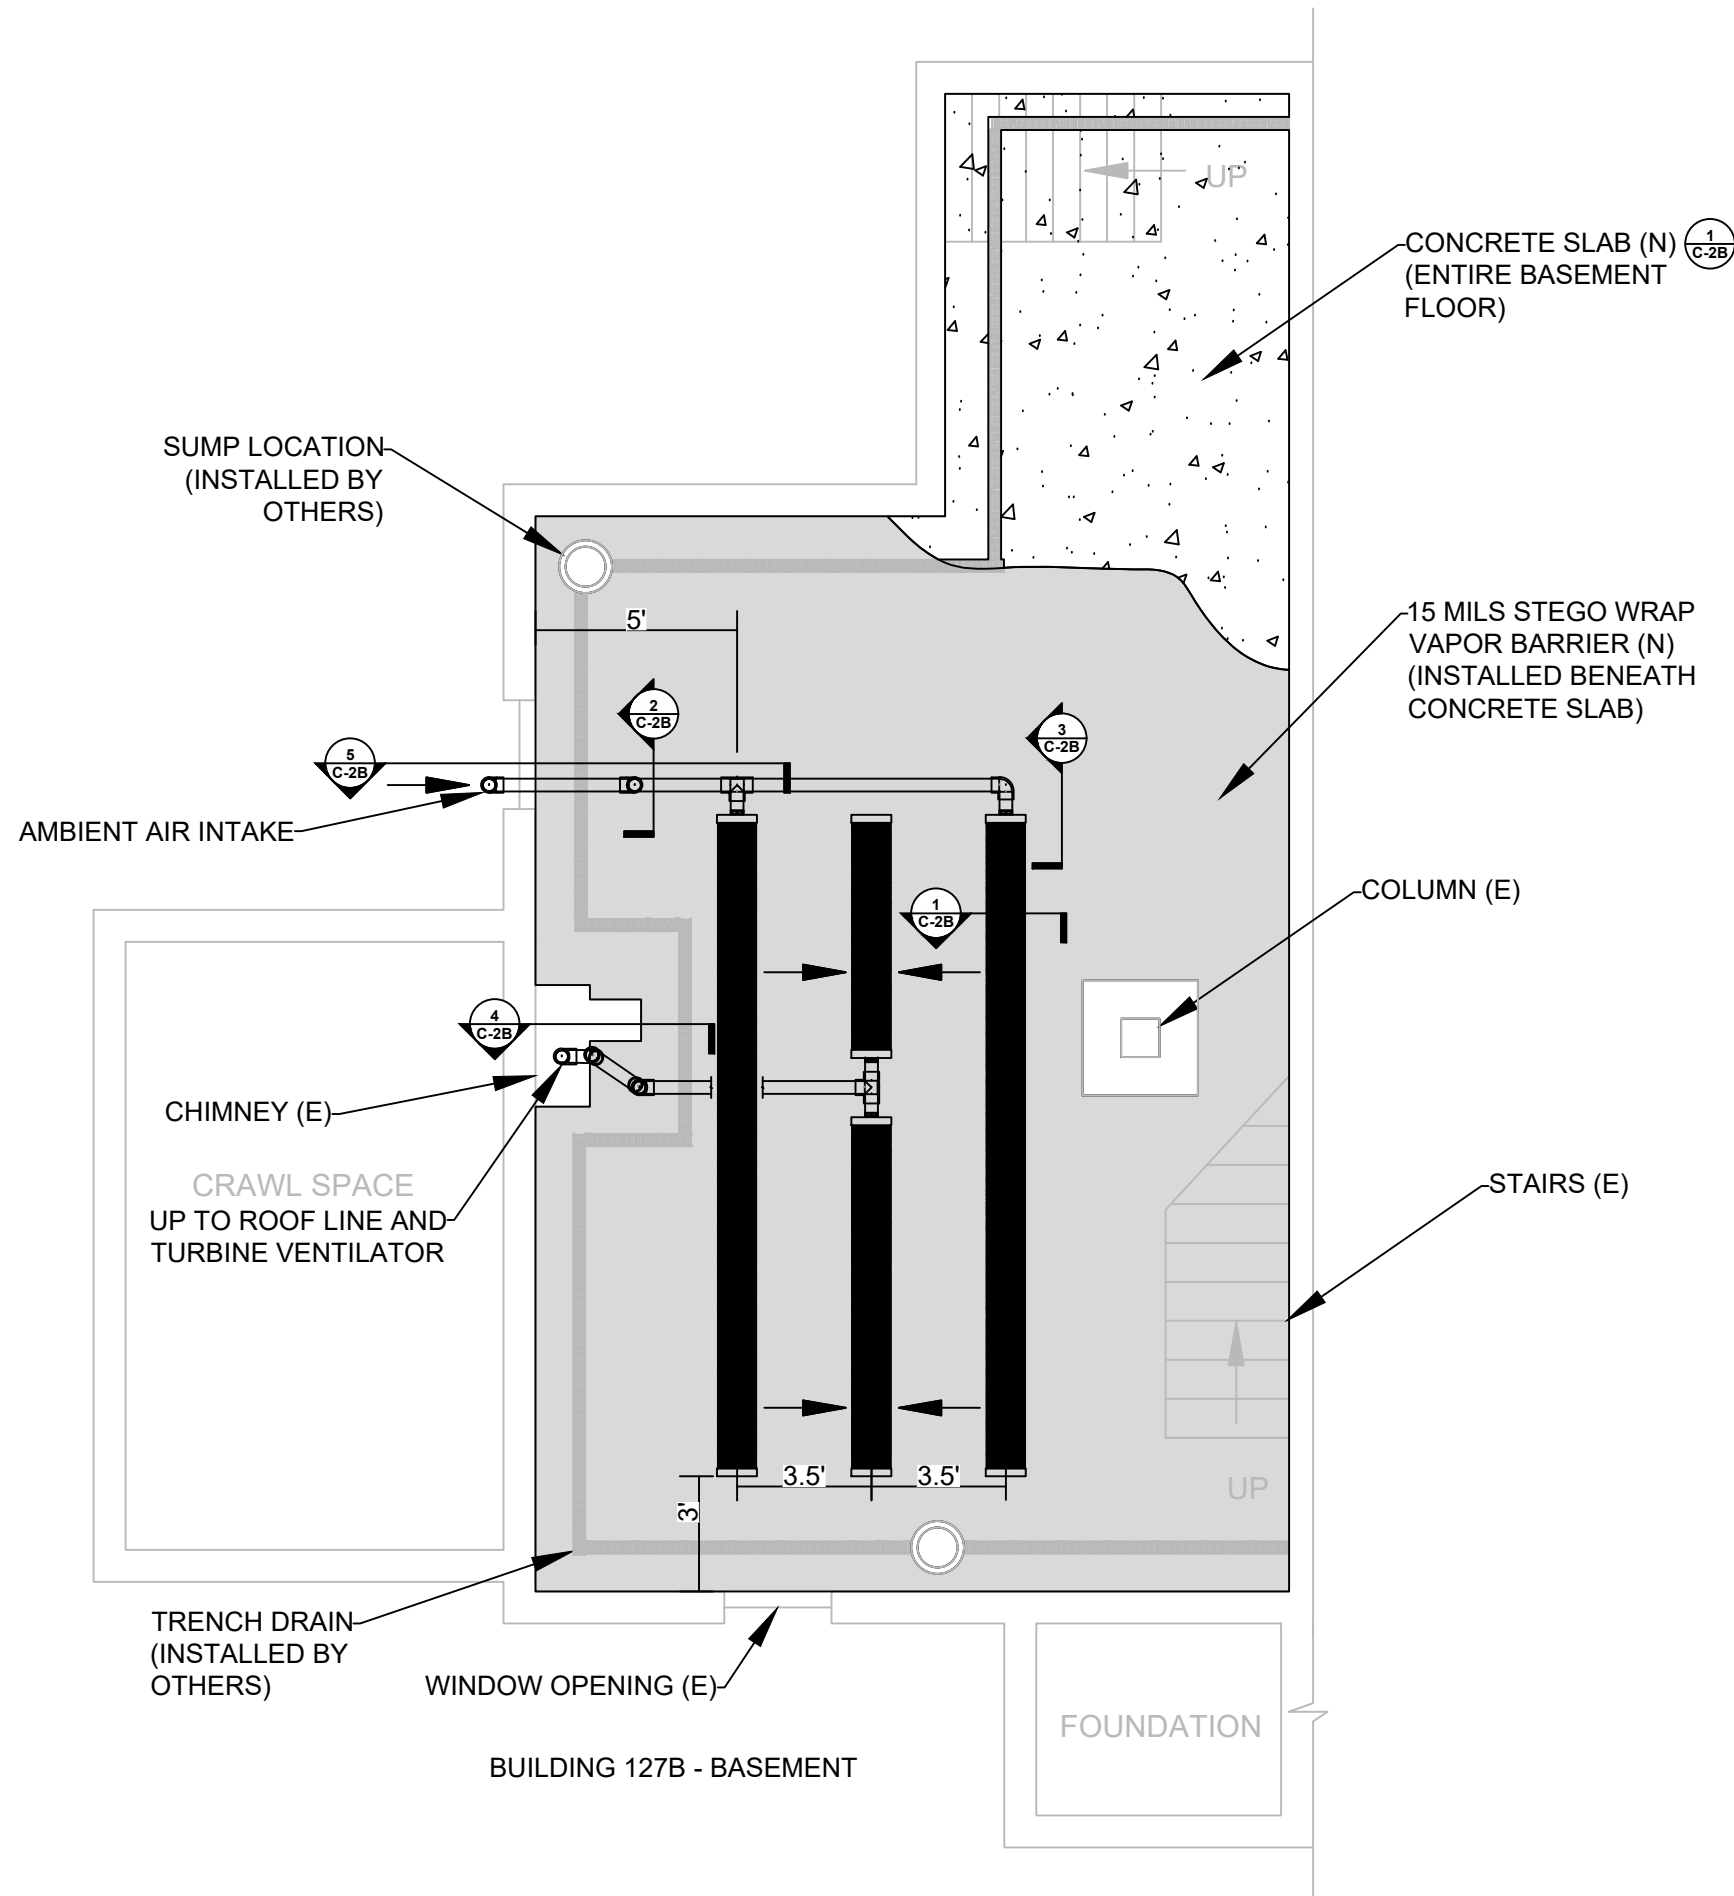
SHEET INDEX	
SHEET NUMBER	SHEET TITLE
C-1	TITLE SHEET
C-2A	127B SUB-SLAB VENTING SYSTEM PLAN
C-2B	127B SUB-SLAB VENTING SYSTEM DETAILS

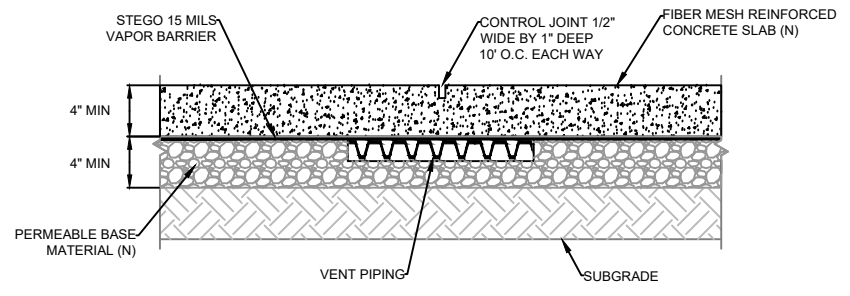
1
C-2A
TYPICAL VENT PIPE AND CONCRETE SLAB
(NOT TO SCALE)

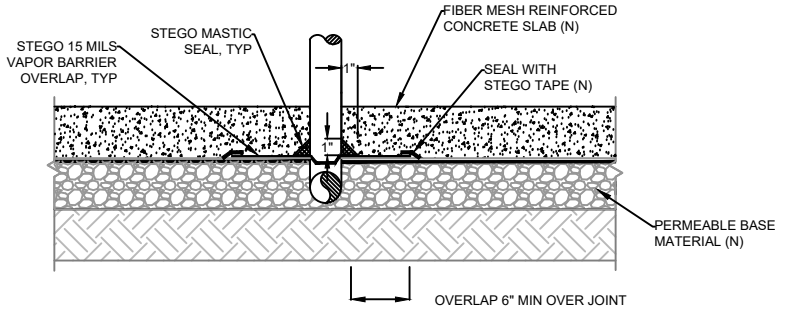
2
C-2A
TYPICAL VENT PIPE SLAB PENETRATION
(NOT TO SCALE)

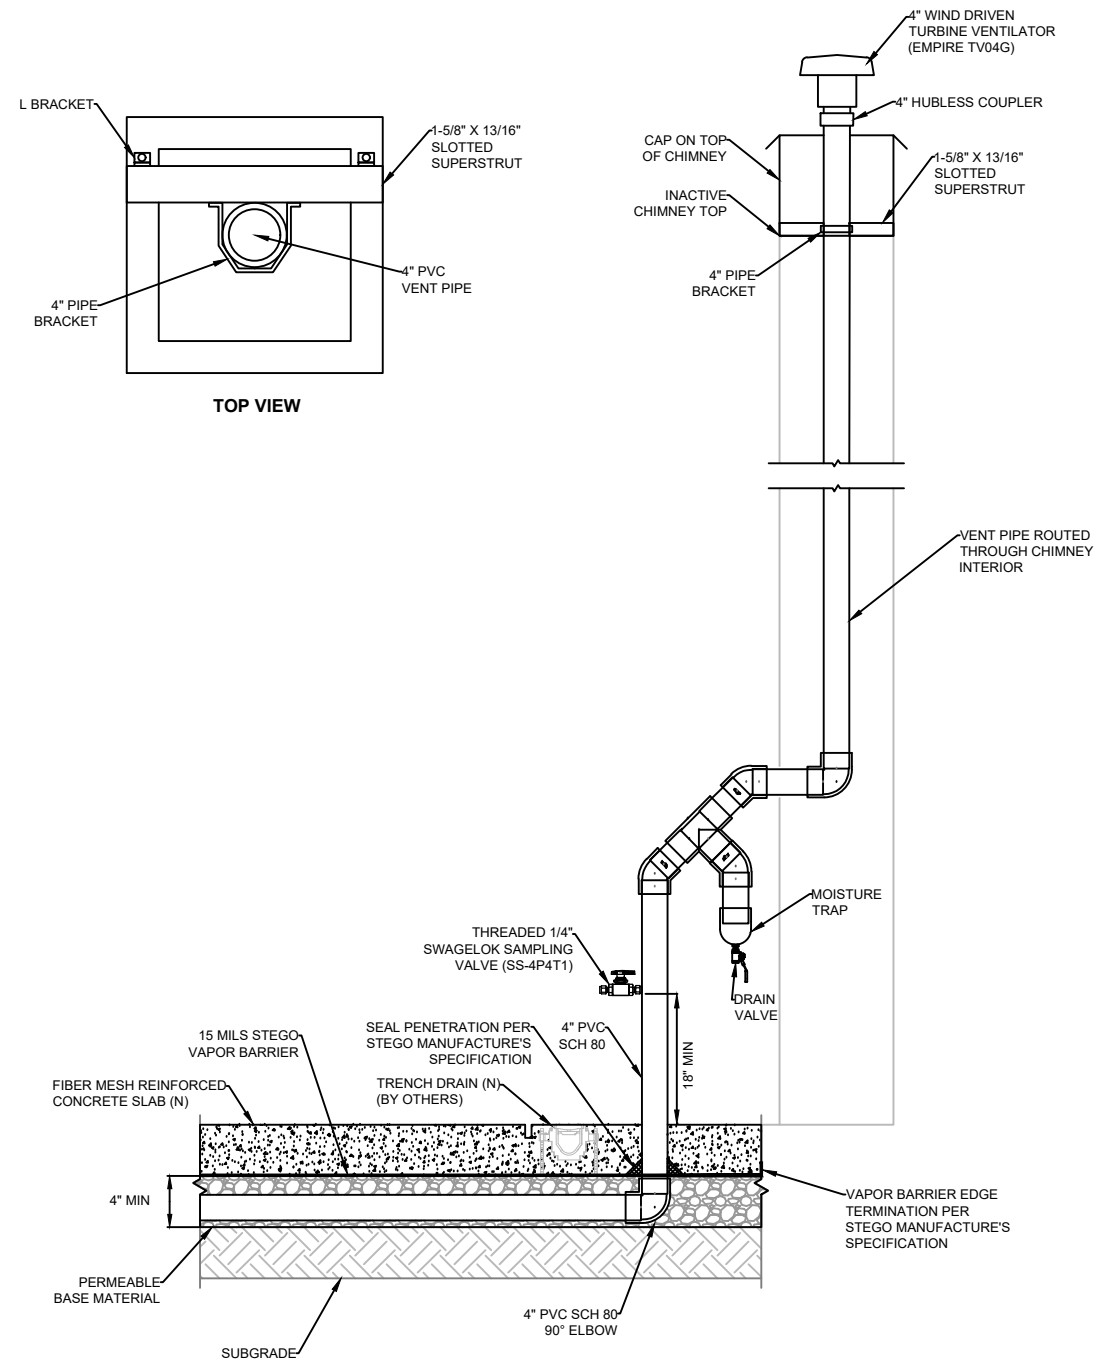
4
C-2A
VENT PIPING
(NOT TO SCALE)

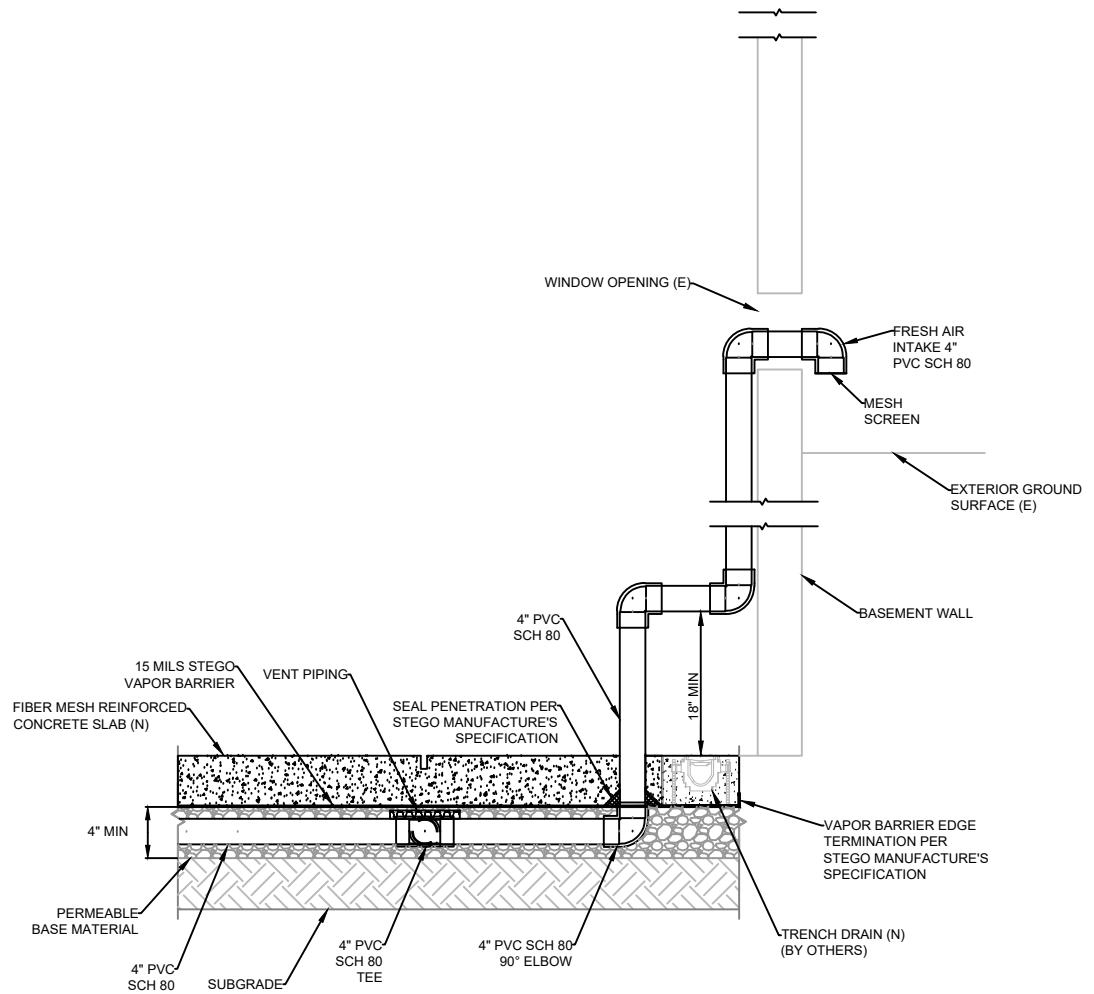
5
C-2A
AIR INTAKE PIPING
(NOT TO SCALE)

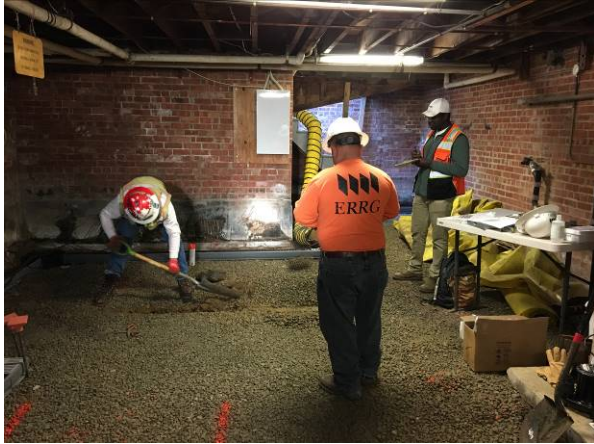
Photo 1: Initial VMS Layout and Trenching

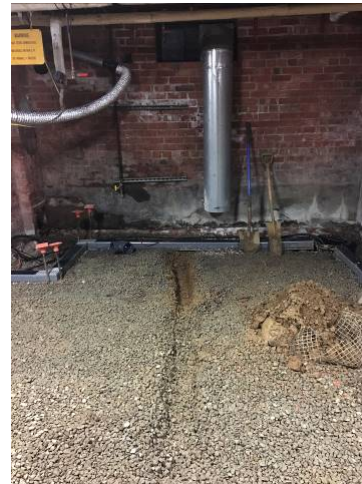
Photo 4: Trenching

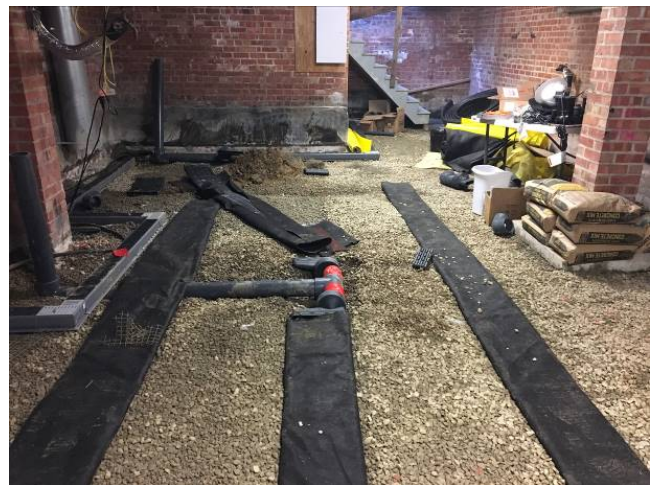
Photo 6: VMS Piping Installation

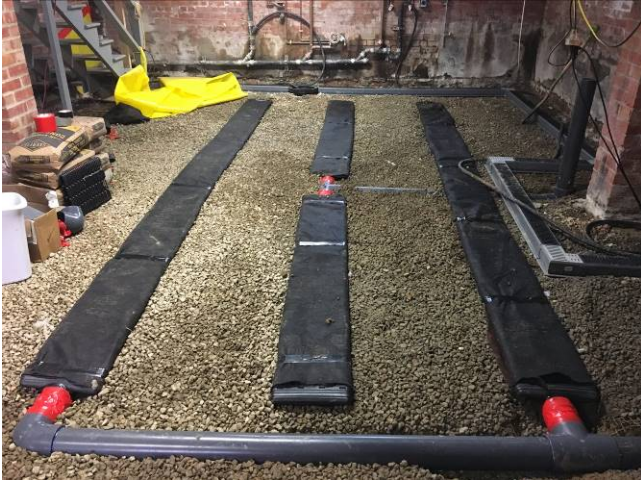
Photo 7: VMS Piping Installation

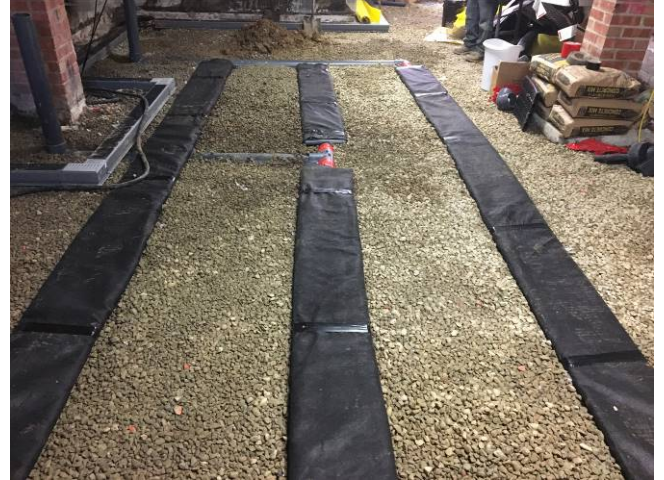
Photo 8: VMS Piping Installation

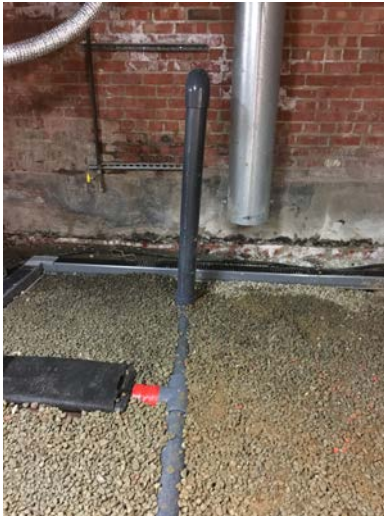
Photo 9: Fresh Air Intake

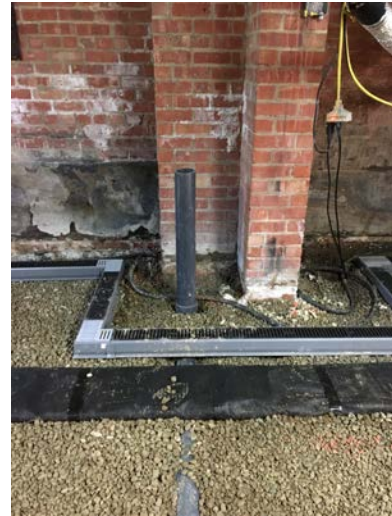
Photo 10: Vent Riser

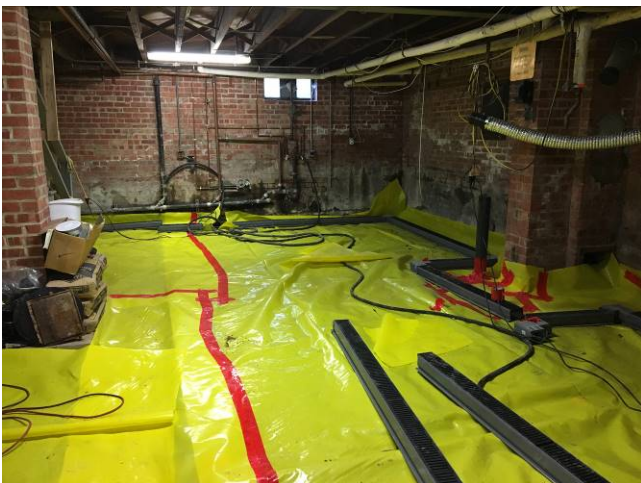
Photo 11: Vapor Barrier Installation

A vapor barrier consisting of approximately 750 square feet of 15 mil-thick, Stego® was installed on top of the permeable base layer and SSVS. The vapor barrier was installed over the entire basement footprint. Vapor barrier layers were laid down with minimum 6-inches overlap and seams sealed using Stego® Tape. SSVS pipe penetrations were sealed using a combination of Stego® Tape and Stego® Mastic per manufacture's recommendations.

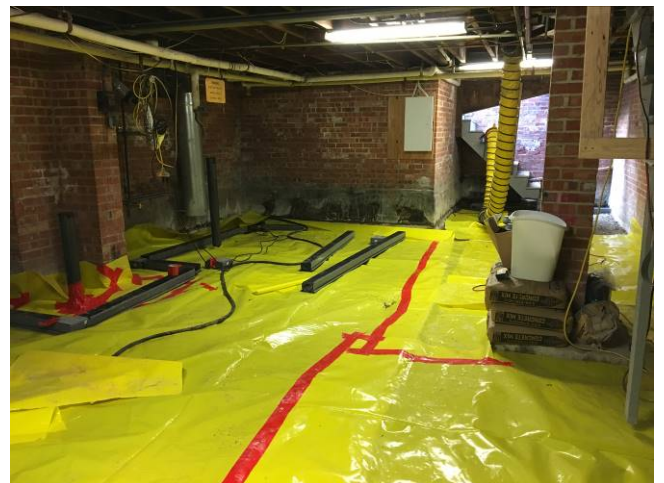
Photo 12: Vapor Barrier Installation

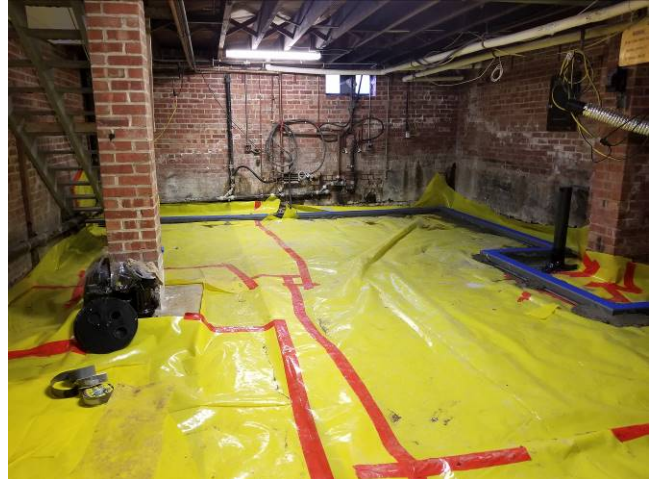
Photo 14: Pre-concrete

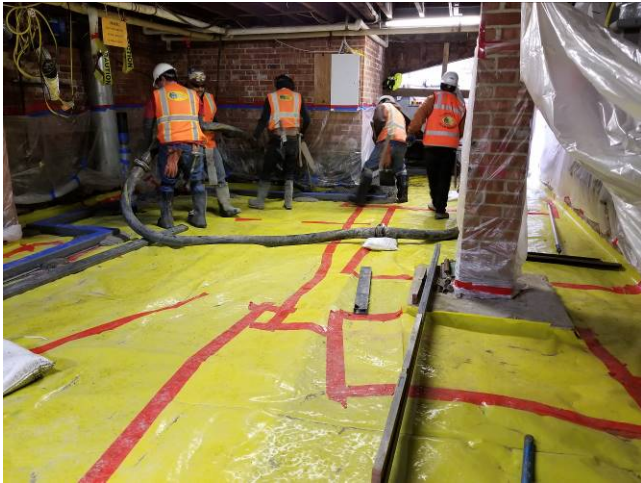
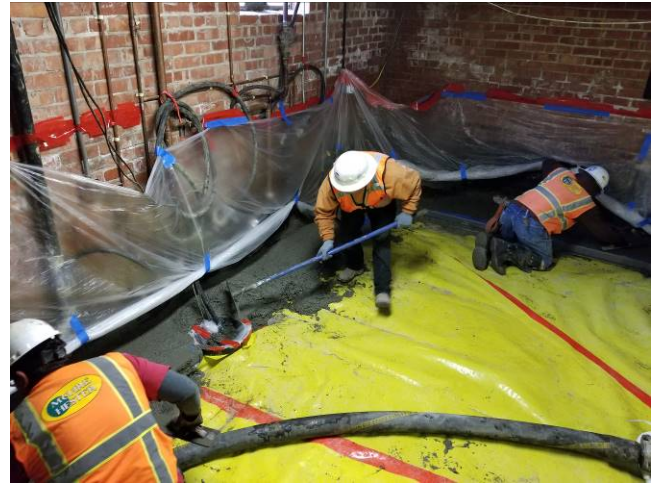
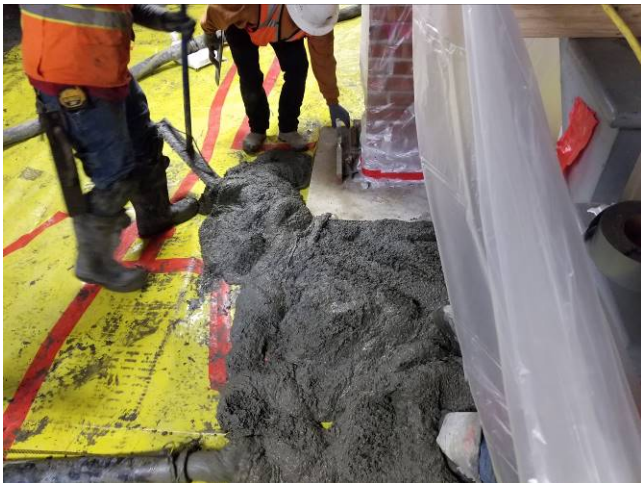
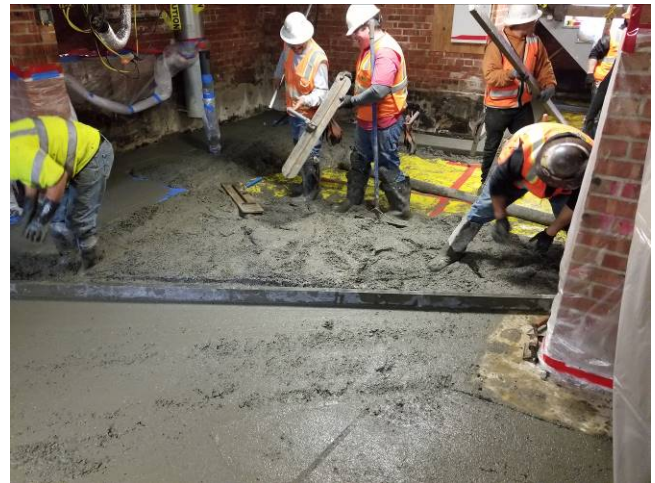
Photo 15: Concrete slab installation.

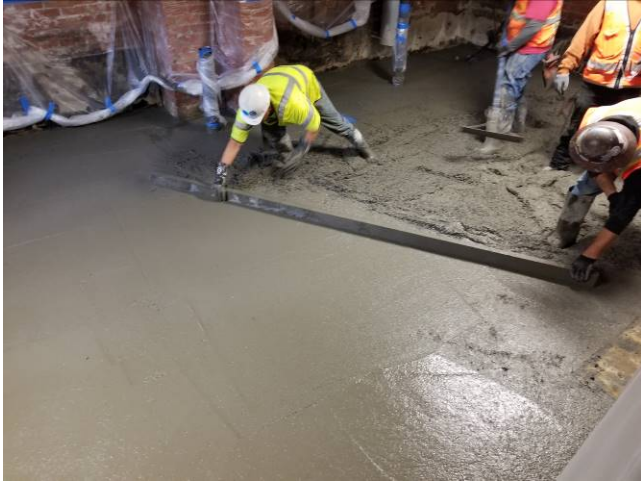
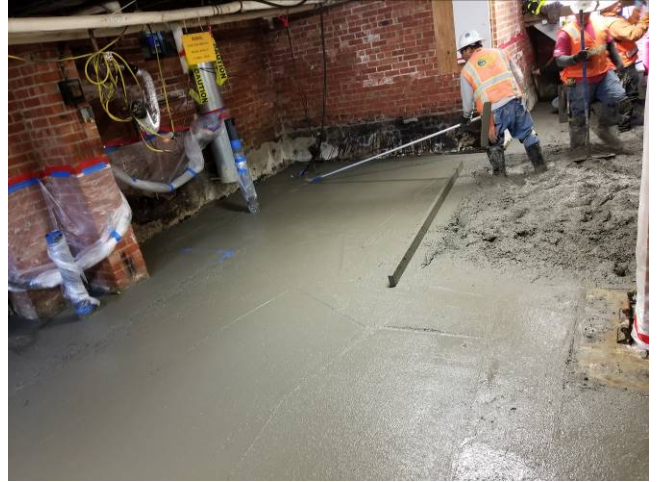
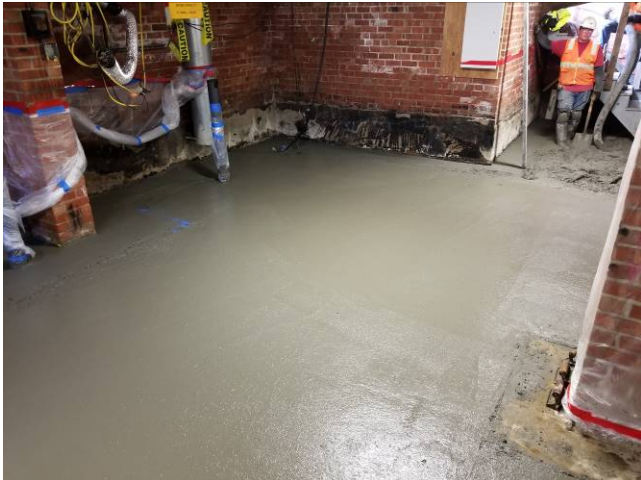
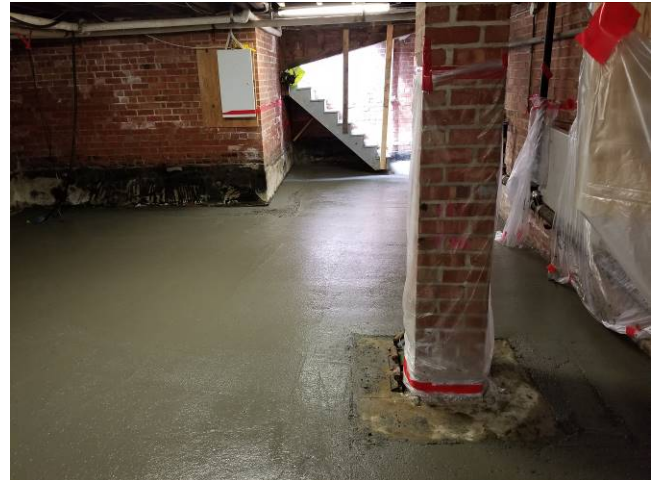
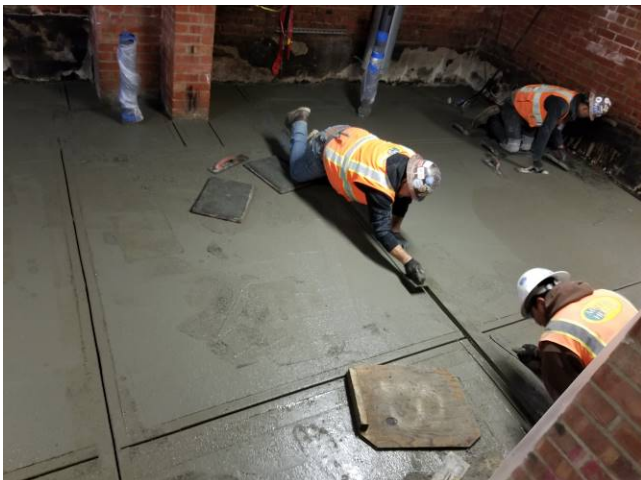
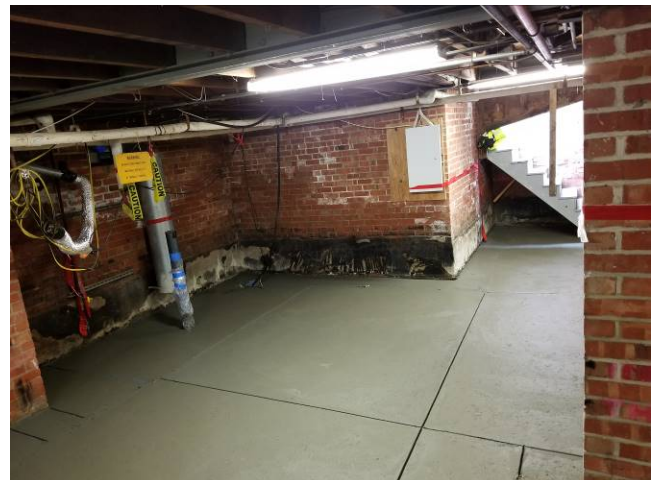
Photo 19: Concrete Slab Installation

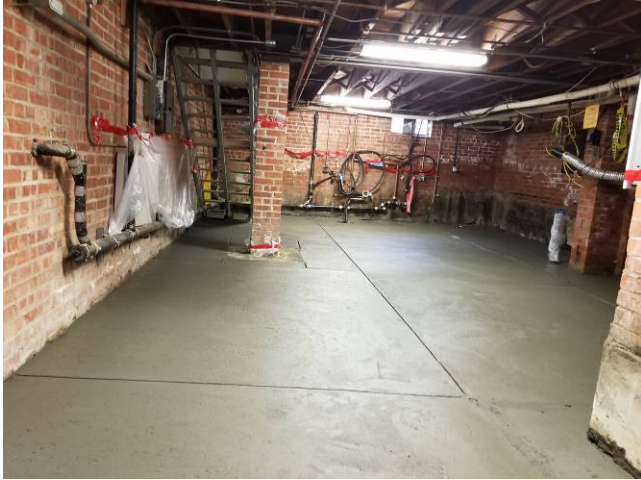
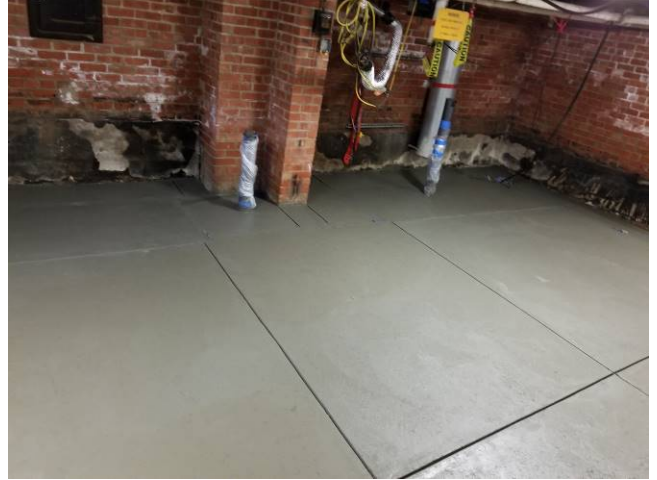
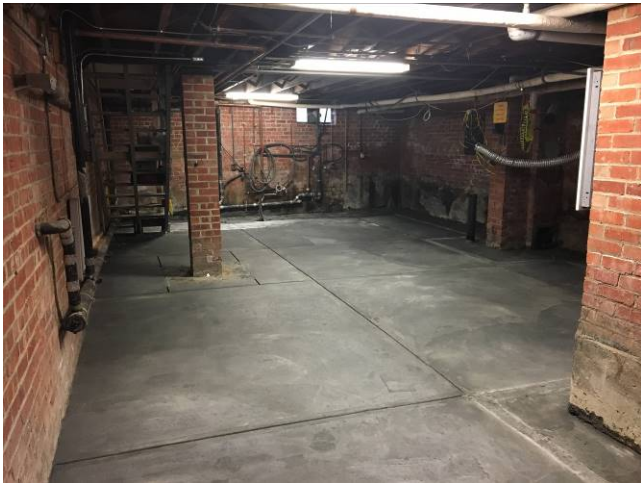
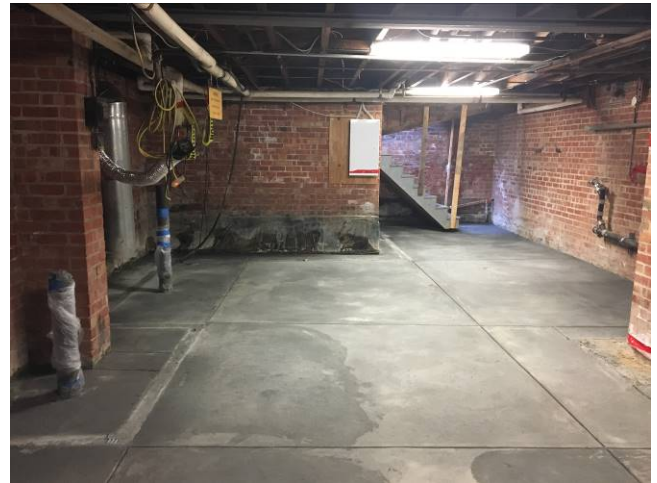
Photo 25: Concrete Slab
