Subject: Construction Completion Report – Vapor Mitigation System
Building 127B Riley Avenue
Section BR11-1 Fuel Distribution System
Riley Avenue, Presidio of San Francisco, San Francisco, California

Construction Completion Report
Vapor Mitigation System
Building 127B Riley Avenue
Section BR11-1
Fuel Distribution System
Riley Avenue
Presidio of San Francisco, San Francisco, California

August 30, 2019

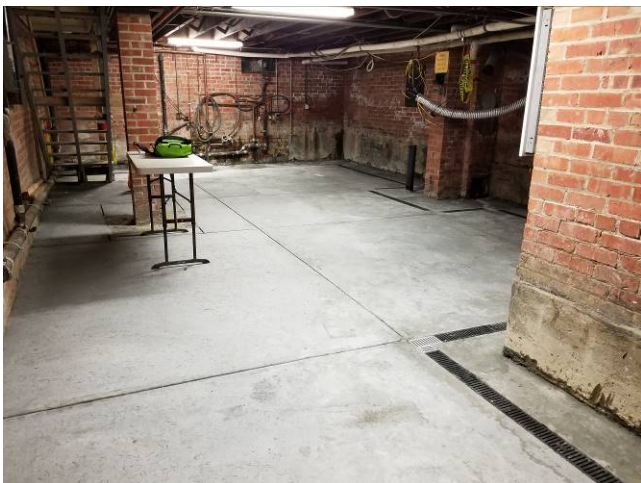
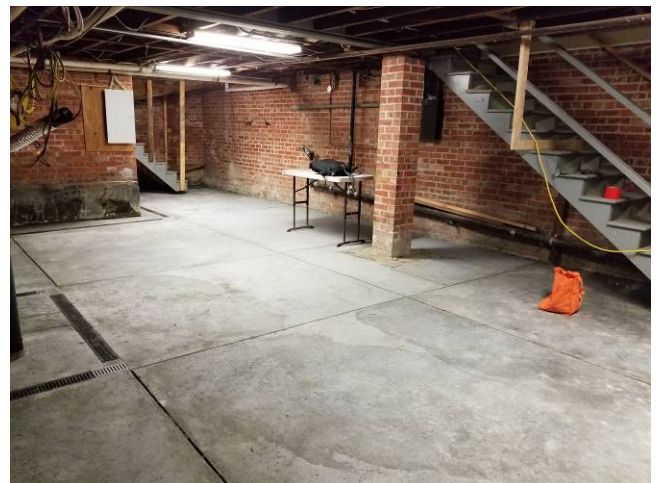
Photo 29: Concrete Slab (cured)

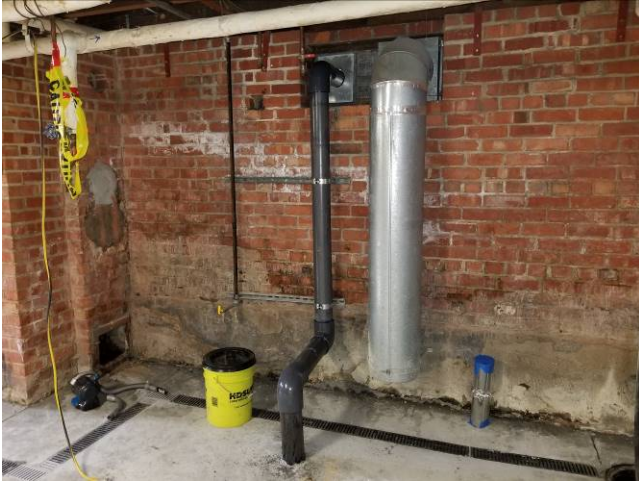
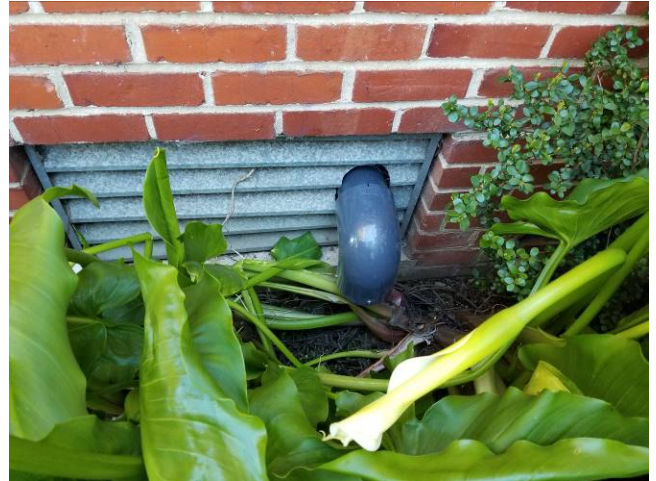
Photo 31: Fresh Air Intake

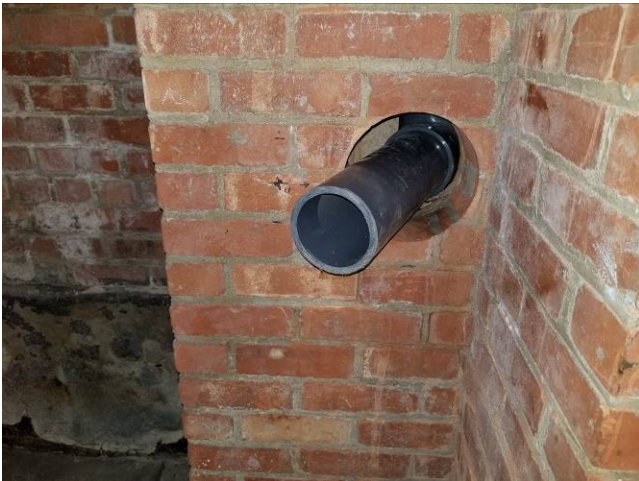
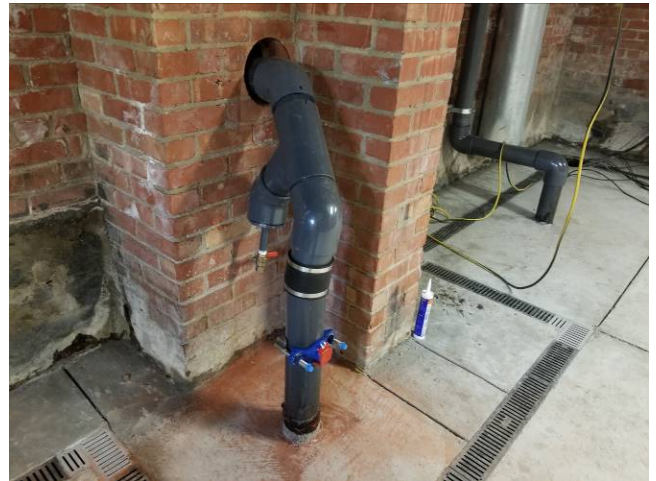
Photo 33: Vent Riser

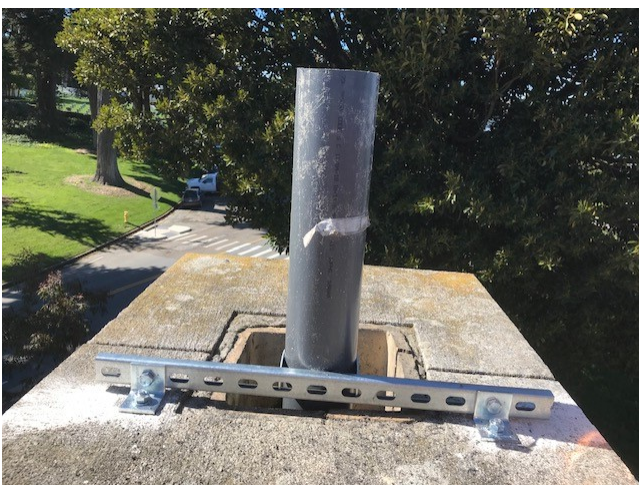
Photo 35: Vent Riser (top of chimney)

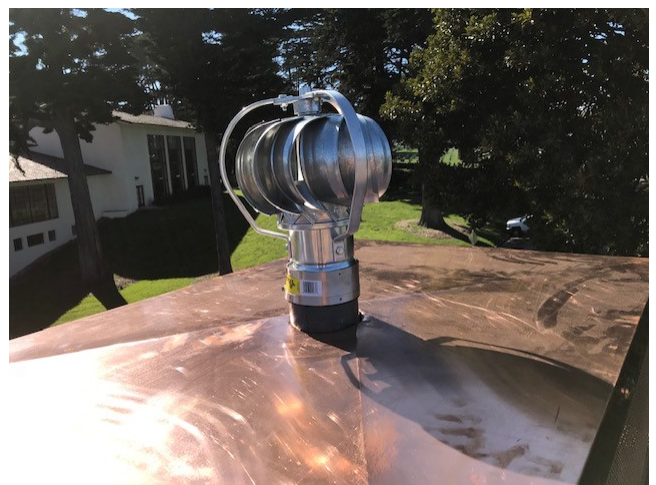
Photo 36: Wind-driven Ventilator
