**Re: Final Five-Year Review Report
Lendrum Court**

**Presidio of San Francisco
San Francisco, California**

Lendrum Court Five-Year Review Site Inspection
 Lendrum Court, The Presidio of San Francisco, Photograph Log

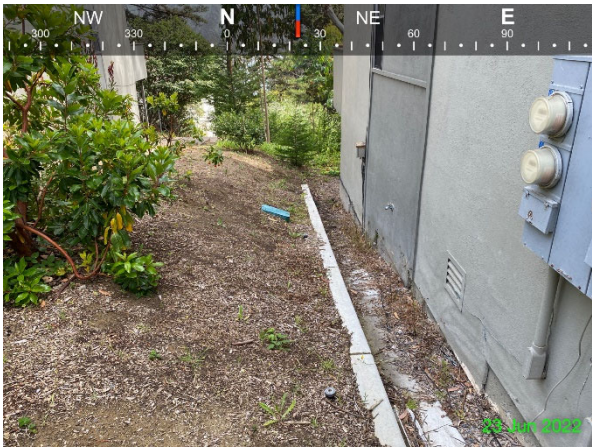
Photo 1: **6/23/2022** – View of intact hardscape and drainage from southwest corner of Building 1279.

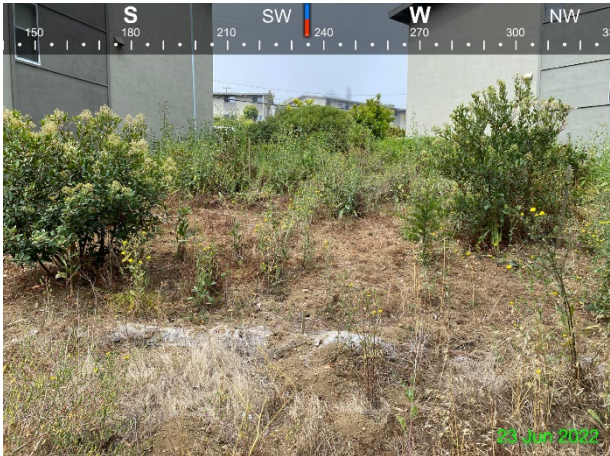
Photo 3: **6/23/2022** – View of vegetated cap between buildings 1278 and 1279. Evidence of burrowing activity is present in the foreground.

- Maintenance to recompact soil and replace gravel bags was performed on 10/28/2022.
- Burrowing activity was observed in the vegetative cap to the east of Building 1258 and the south of Building 1278. No evidence of damage to the cover, such as visible debris, was noted.

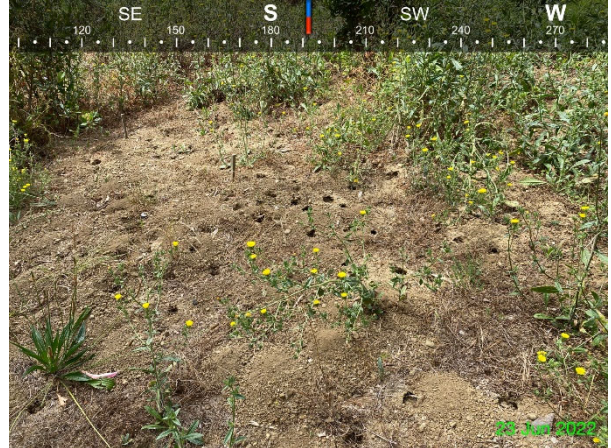
- Patches of bare earth were observed to the south of Building 1278 and correspond to the burrowing activity noted south of Building 1278.
 - Erosion control blanket and straw wattle was installed 10/28/2022 to address bare soil at various locations across the site.

Photo 4: **6/23/2022** – Area of bare exposed earth where burrowing activity is present in the area between Buildings 1278 and 1279.

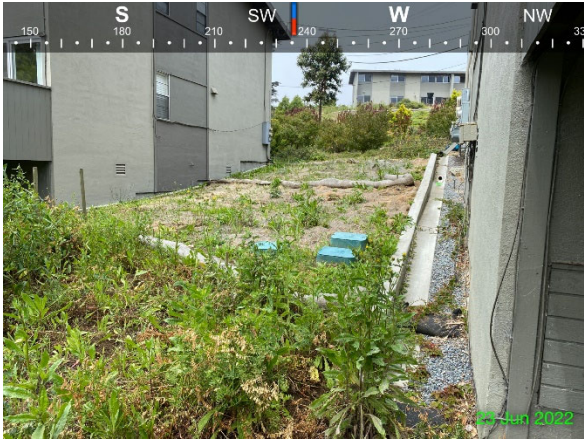
Photo 7: **6/23/2022** – View of erosion protection between Buildings 1278 and 1259. Intact hardscape and drainage shown from the southeast corner of building 1278.

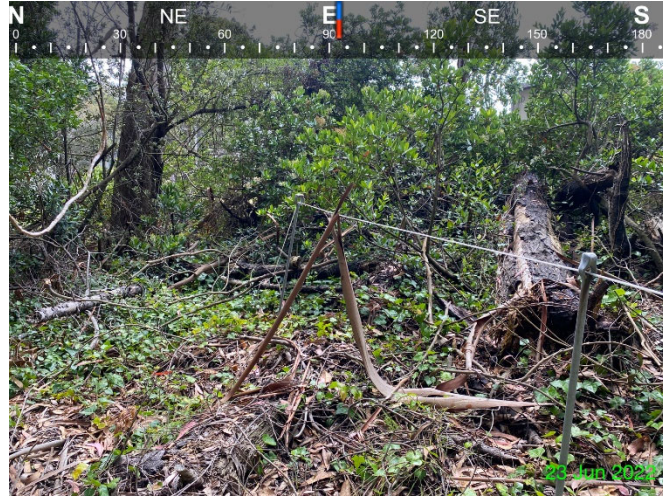
Photo 16: **6/23/2022** – View of undisturbed forest area in LUC Area B and the surrounding fence. A tree has fallen down on a portion of the fence.

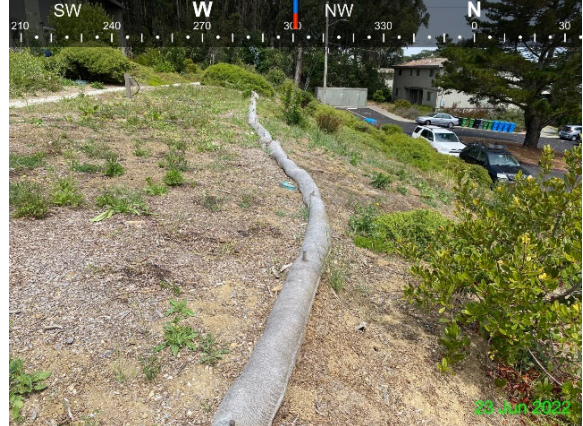
Photo 18: **6/23/2022** – View of vegetated slope, erosion blanket, and former planter box area to the northeast of Building 1257.

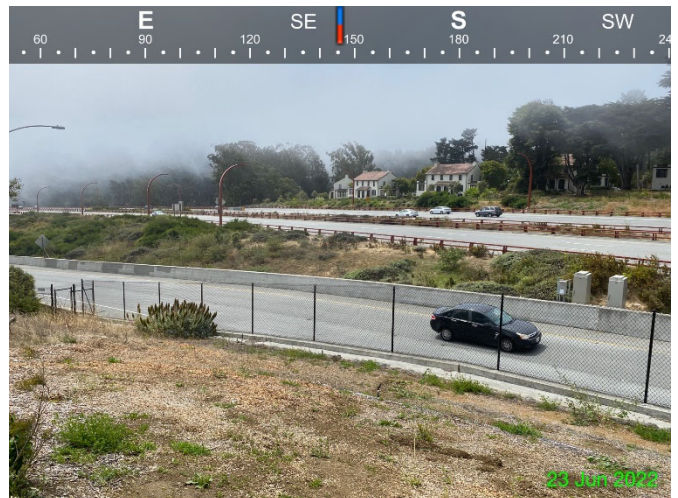
Photo 24: **6/23/2022** – View of the incinerator area with healthy vegetation and no signs of trespassing.
