BUILDING 105

Historic Structure Report

FINAL
May 2015

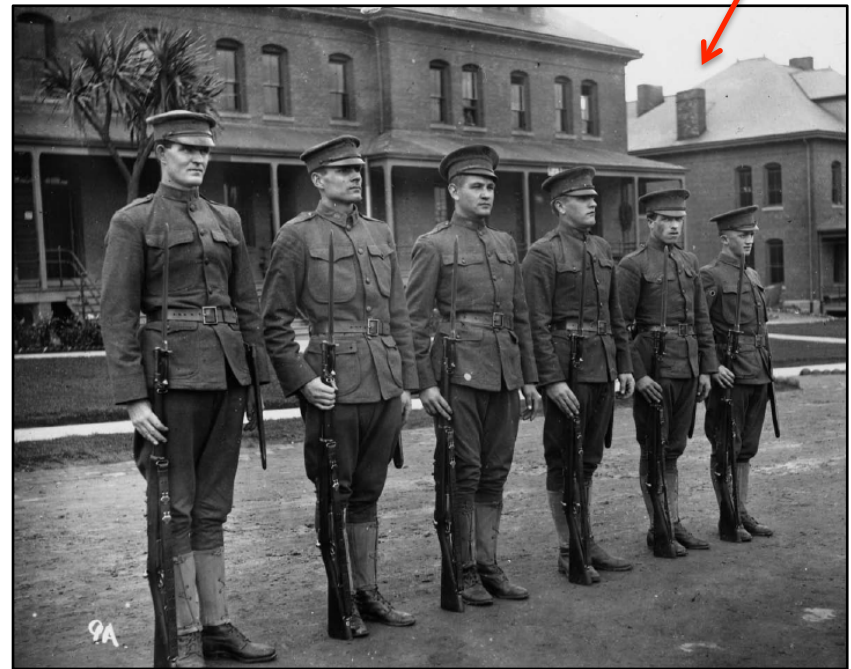
Note the apparent somewhat darker color of the wood trim on the Montgomery Barracks buildings as opposed to the current bright white painted finish. Also visible is the end chimney (red arrow) that was subsequently removed and replaced with a dormer on all five buildings. Source: GGNRA-PARC, circa WWI-era (1914 – 1918).

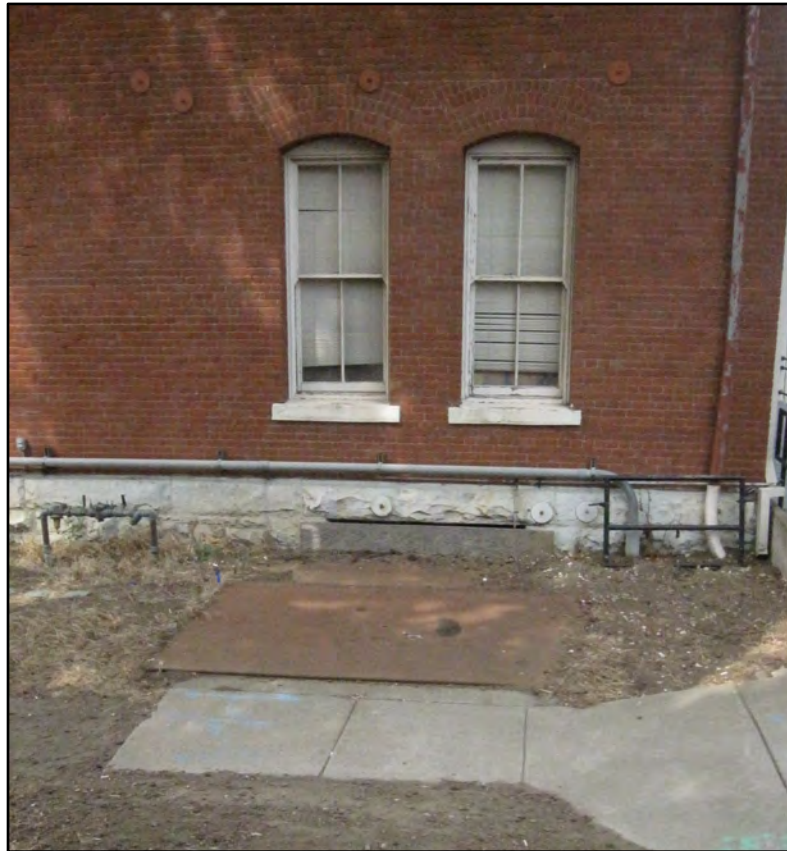
A detail of the east end of the south elevation with the basement stair covered with an access board.

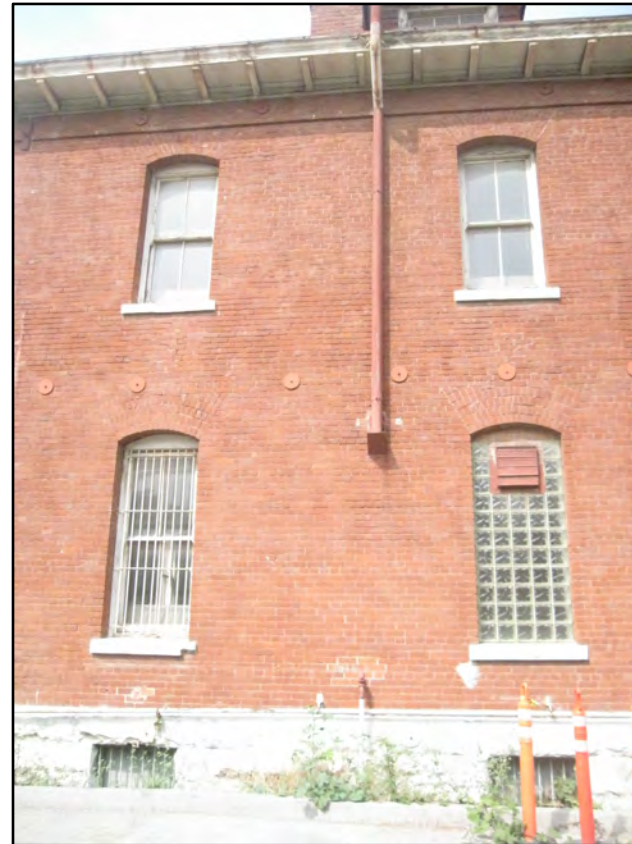
A detail of the south elevation showing one of the windows that has been infilled with glass block inserted at an unknown date.

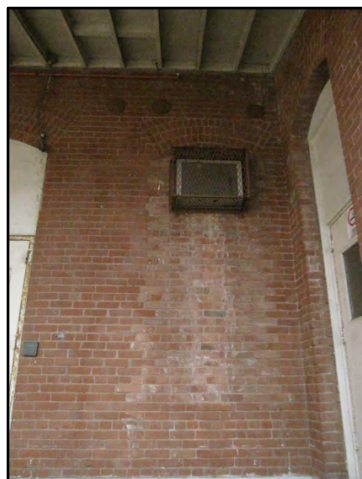
Left: A detail of the bricked-in window on the west veranda

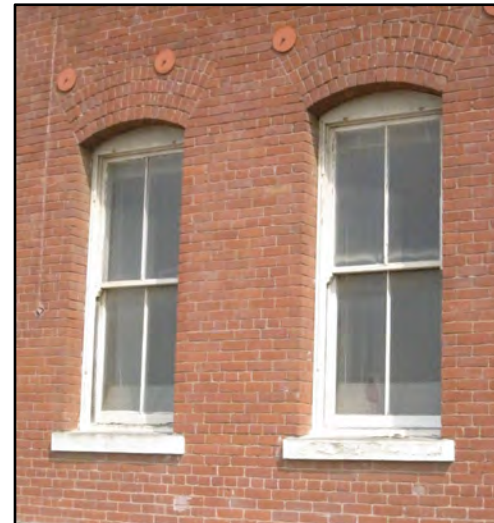
Typical exterior brick wall surfaces. Common bond pattern with arches above windows. Areas of repointing can be seen in some locations.

The brick walls have been sandblasted. The brick and mortar will require strength testing and appropriate treatments will need to be developed in conjunction with a conservator experienced in masonry construction. Re-pointing is required in some locations, especially where water has run down the façade at areas where there are missing, damaged or leaking downspouts or gutters. This is particularly true at the brick cornice near the overhanging eaves. The mortar used appears to easily absorb water, which has gradually impacted both the brick and mortar, and causing erosion or "melting" of the masonry.

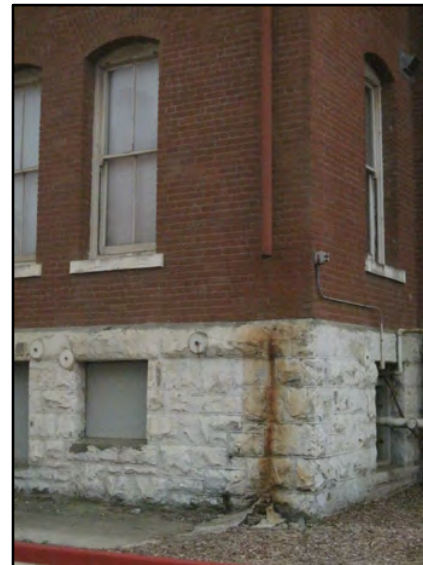
Below Right: Staining from water stream emitted from a broken downspout.

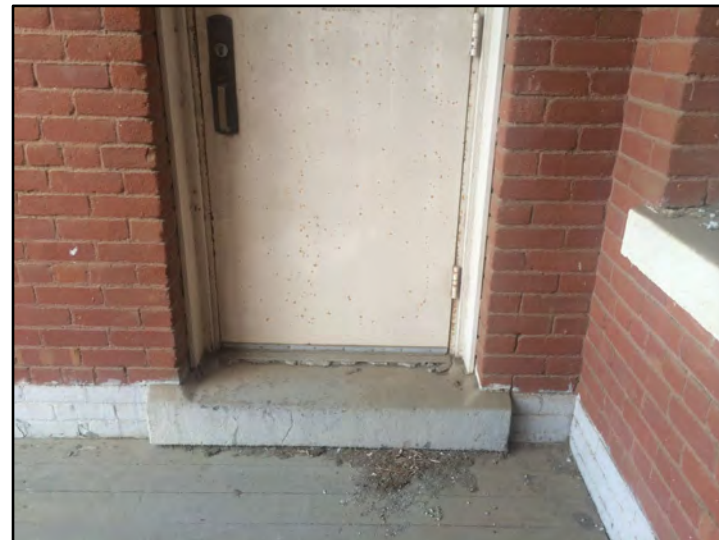
Below Right: While the door from the north stair hall has been replaced the granite threshold remains, although it has been painted to match the grey of the veranda decking.

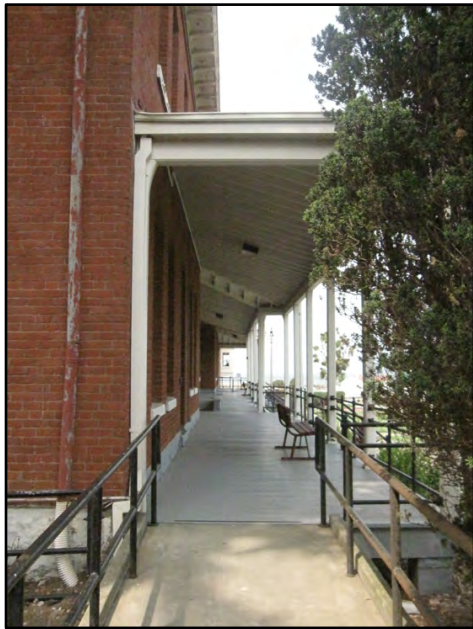
The brick piers that support the west veranda appear to be in fairly good condition. At some point in the building's history the piers, stone foundation and wood porch floor was painted "Army" grey. This is consistent among the Montgomery Street Barracks. The wood elements of the East Veranda suffer from some deferred maintenance and outdated paint coatings; however, they are generally in better condition than the other wood features on the remaining three elevations. It was observed that some of the wood chamfered posts that hold the porch roof are rotting at the base.

Above: A view looking north down the east veranda

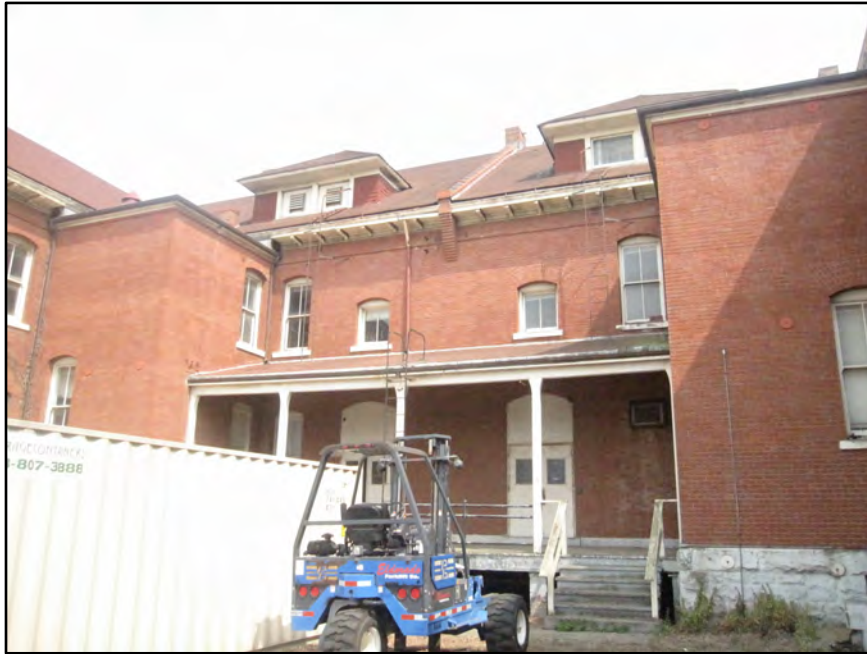
Left: A window that has been bricked up at the West Veranda; this is also visible in the photograph above to the right of the door just at the top of the visible stair.

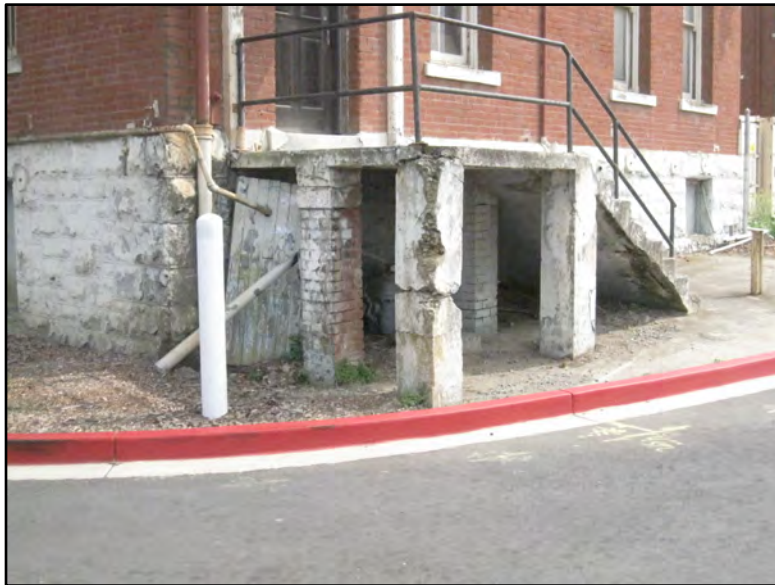
Above: The rear stair and stoop of the south wing. This wing had an exit door from the basement. The north wing (shown left) did not have an exit door.

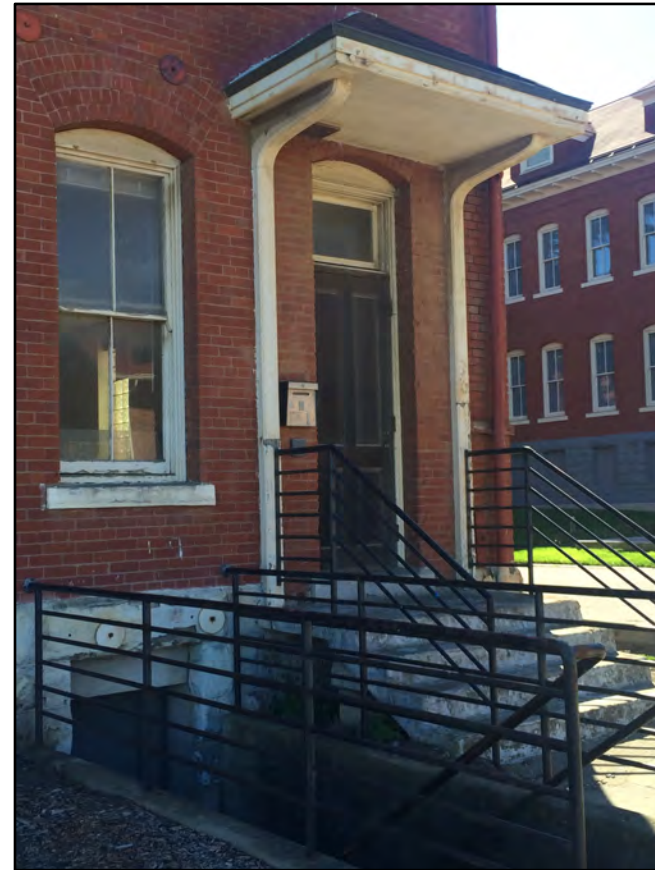
The rear wing exit porches and affiliated features including the overhang supports, brick and concrete piers, stairs and metal railings are in very poor condition. The porch at the northwest corner is in particularly bad shape. Several of its brick and concrete piers appear to have been damaged by vehicles that travel around the almost immediately adjacent Lincoln Boulevard. These porches appear to have once had a vertical wood board, enclosing wall connecting the brick piers and concealing the space under the porch. This feature is either missing or severely damaged in these locations.

Left: The damaged pier at northwest corner of the north wing's small porch and exit stair. The door here accesses office 136 at the first floor.

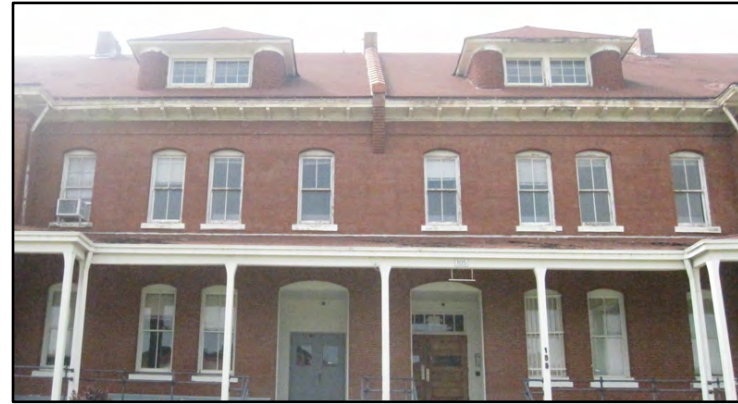
The “Two Company” configuration of the building is evident in the brick parapet wall that bisects the roof. This feature is capped with decorative terra cotta tile that is damaged in some locations and even exhibits some dark mold or biological growth. Where crotch joints occur on the roof there is almost always associated water infiltration.

Above: The front dormers and cap of the brick dividing wall at the east elevation.

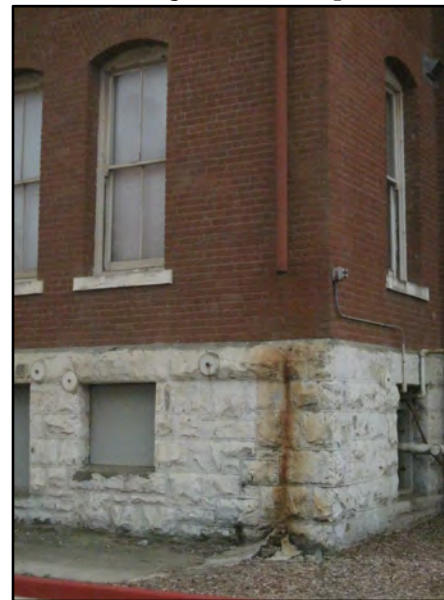
Below: Staining where downspout is missing

Generally, the drainage system includes drains, scuppers, gutters, downspouts, and drain leaders. The original drainage system was fairly complex as it needed to accommodate water removal from a variety of intersecting roofs, dormers and roof valleys. Many of these elements are damaged, missing or beyond repair. Many downspouts are disassociated at their seams, creating streaming water down brick facades. Of particular concern are the many scuppers, which originally directed water away from the foundation, but that now do not collect water correctly and water appears to splash or even collect against the masonry walls. Further, the window wells and basement exit doors at the foundation level also had a drainage system that appears to be impaired. Lastly, rust associated with an aging drainage, gutter and downspout system has left stains in many locations of the masonry walls.

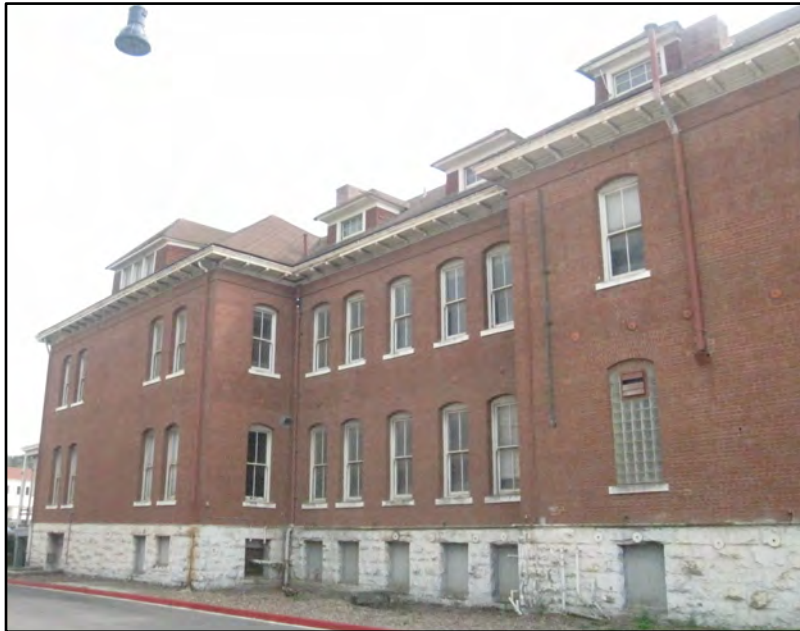
The dormers that face the front Parade Ground are in the best condition. The dormers are sheathed with the same composition shingle roofing material as the main roof. This material is in a fairly deteriorated state. Many dormers have broken windows and there are many areas where flashing is failing.

*The dormers along the north wing, north elevation.
Note these dormers are smaller than those that face the
Parade Ground.*

Repair and rehabilitate original attic dormer windows. Where glazing is missing provide new glass. Repair any wood structure and the associated flashing at the dormers and provide new composition shingles to sheath the dormers.

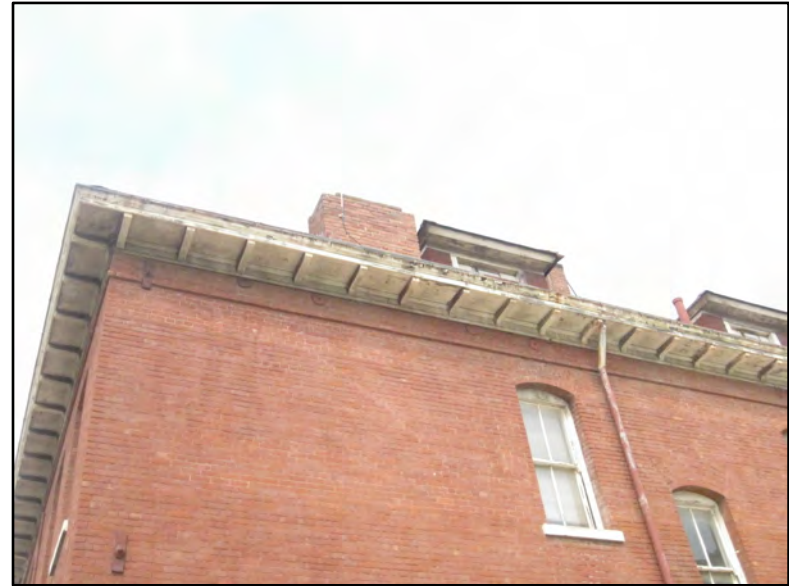
A view of a downspout from the roof and cornice down the brick exterior wall.

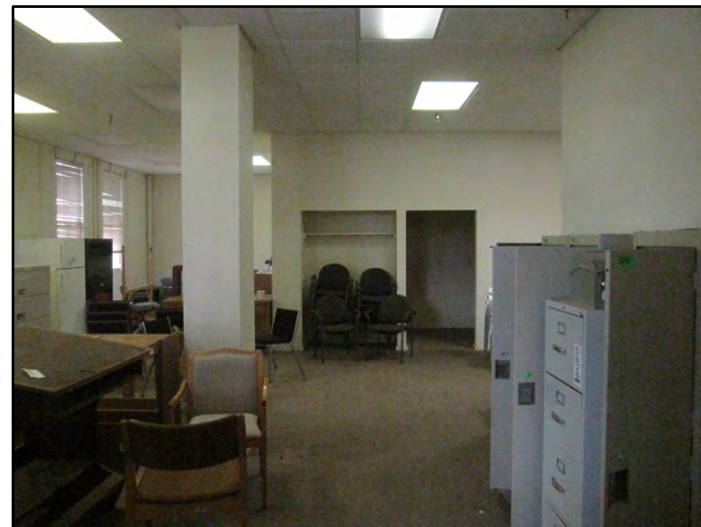
“Most cast-iron columns on first and second floor were boxed in, and the open areas of the boxes were used as chases for conduit.”

These features likely remain and were not likely heavily damaged when enclosed. It does not appear that any of these features were removed during the FEMA renovation. The columns may have originally been unpainted, then they were painted and during some eras the bottom portion of the column was dark and the upper portion white.

Below Right: A current view of one of the boxed in columns in Room 112.

Understand that concealed structural elements (columns, post, piers, trusses, brick arches, etc.) are significant and may be primarily intact. These features should be retained and reused wherever feasible and as conditions and code requirements allow. Address life safety deficiencies: rail heights, fire detection and suppression, and exiting.

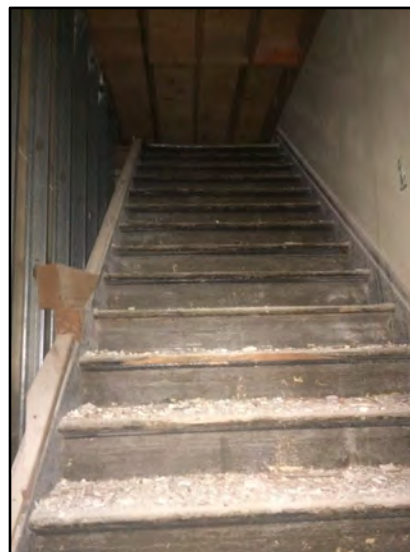
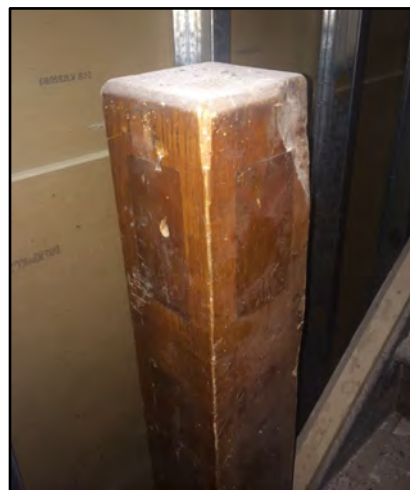
The south stair has been enclosed and capped (floored over) so that no remnant remains on the second floor and it is no longer used. During the course of this HSR project, Presidio Trust staff cut an opening in the wall encasing the stair. The newel post, some wood treads and risers, and the baseboard remain in situ. The top of the stair at the second floor was completely removed to form the flooring for that area. Both the north and south central stairs retain their newel posts and they are in similar condition to those restored in Buildings 101 and 103. It appears that the balusters, handrails and other decorative details of these stairs are missing.

Above: The hidden stair from the first floor in the north barracks.

Below: The newel post uncovered.

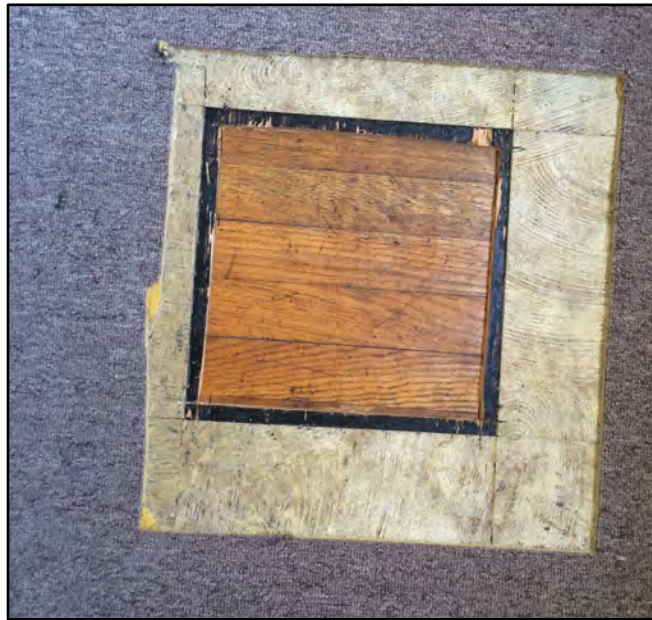
During the course of this project, Presidio Trust staff exposed portions of the wood floor under carpeted areas in various locations of the building. It appears that in many locations at the first and second floor the original wood floor is present and could possibly be cleaned, stripped, re-stained and reused in a future project. The wood flooring material in the other Montgomery Barracks was typically Douglas fir. It is likely that this is the material used in Building 105.

Above: The wood flooring exposed at the first floor.

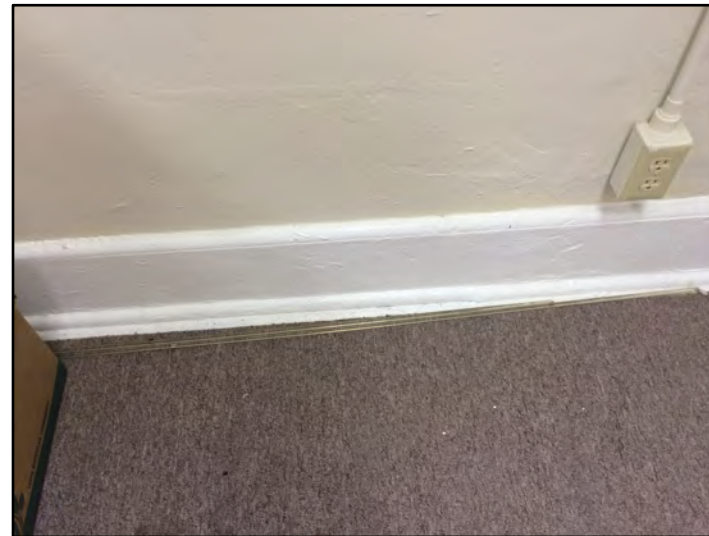
Generally, wood baseboards are extant and in fairly good condition (painted white) at wall locations that correspond with perimeter walls. Especially, at the first and second floor locations of what were the large open rooms of the dormitories and mess hall.

Above: The baseboard in Room 113. This corresponds with the east elevation perimeter wall.

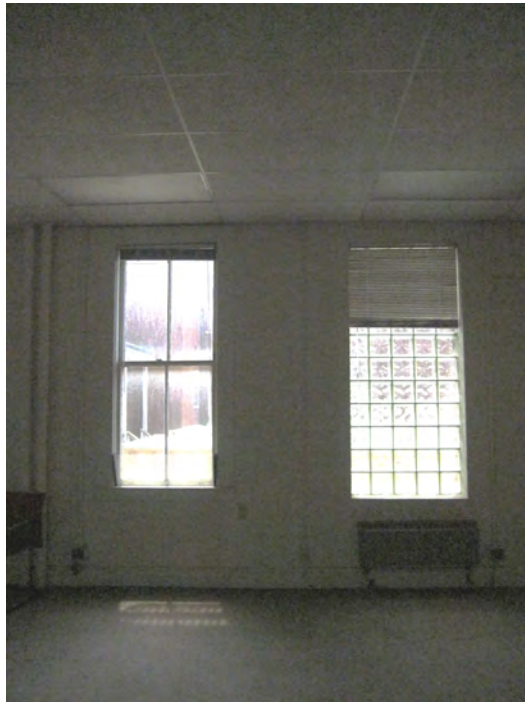
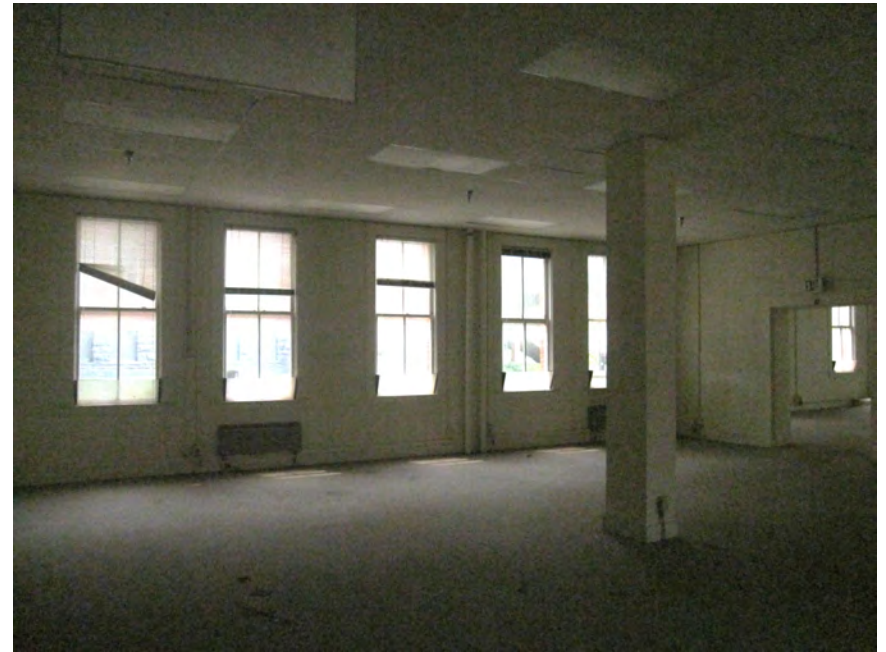
At the interior the wood windows are generally in good condition with paint coatings in fair to good condition. The brass pulls and locks have most commonly been painted but appear to be extant in most cases. Some windows exhibit mold and water infiltration from failed glazing. The window locking mechanism and pull hardware is very simple with most having been painted over. A number of windows exhibit broken panes of glass. Attic windows are operable casements with brass handles. These are in fair condition with some handles broken.

Above: The bank of windows in Room 106, formerly a first floor Mess Hall.

Left: Room 131 looking south at an original window adjacent to a replacement glass block window.

Repair and rehabilitate double-hung, wood windows at first and second floor. This could include removal of windows for cleaning, repair of sash, muntins, glazing, and repainting. Windows with original glazing should be carefully removed and stored during rehabilitation so as to protect the glass.

Install appropriate replacement double-hung, wood windows where glass block or brick infill occurs. New replacement sash windows should match the historic windows to the extent possible.

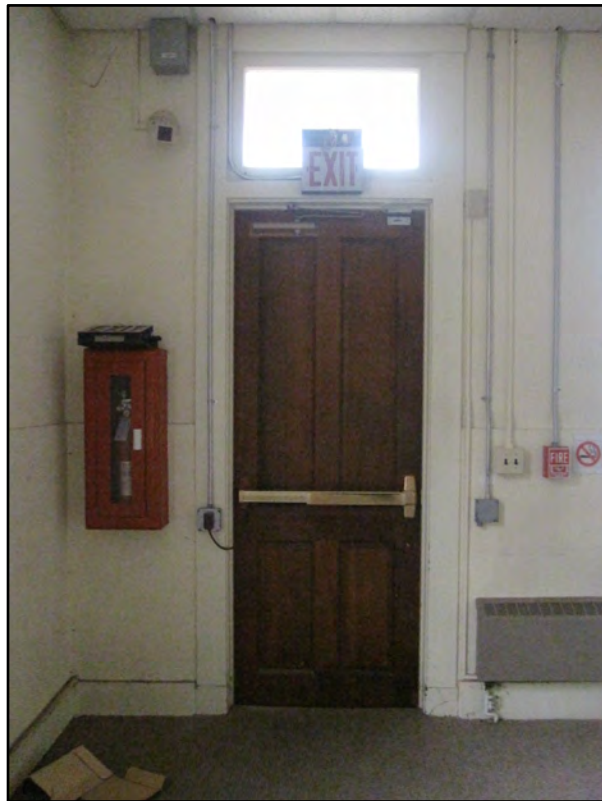
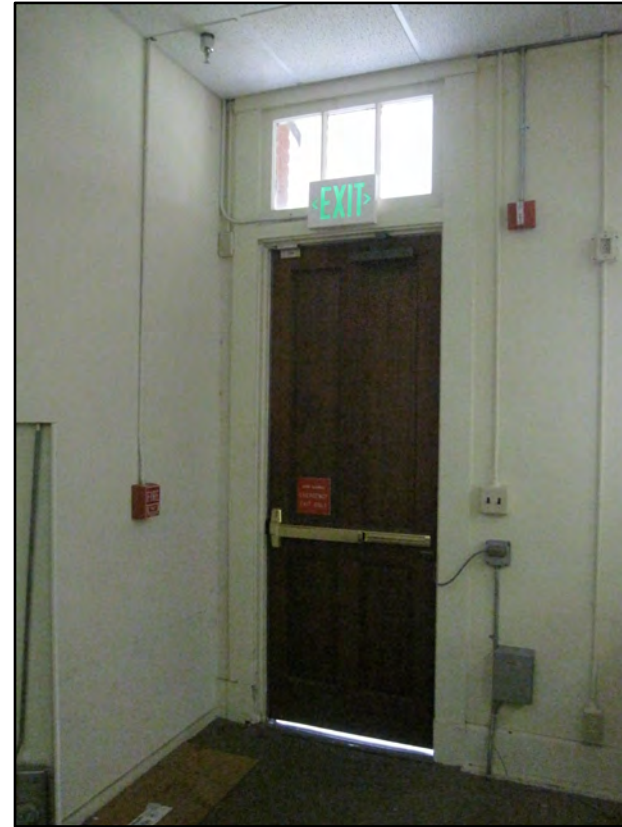
Exterior doors have been discussed above. At the interior locations of exterior doors, especially at Room 112, there appears to be some original wood trim or door framing. This seems to appear at these first floor single exterior doors only. No original interior doors appear to remain in the building; there may be a few original door frames. Most interior room doors are hollow core wood doors from the FEMA era.

Above: Room 112 looking east. This is one of the few doors that retains an original transom. It also retains the original trim surround the door and there is original baseboard in this location as well.

Left: Room 105 looking west. Typical replacement door, but where the original transom configuration remains in place and some original wood door trim or framing may be in place or was matched well during replacement.

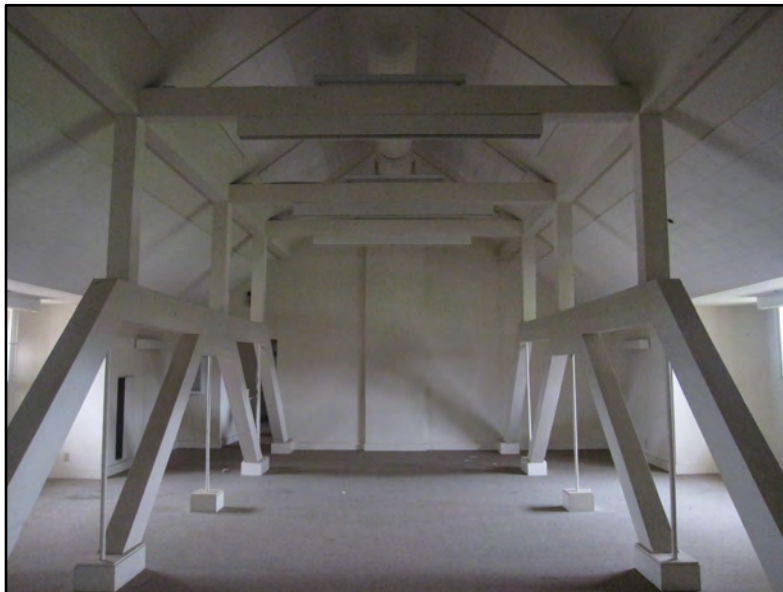
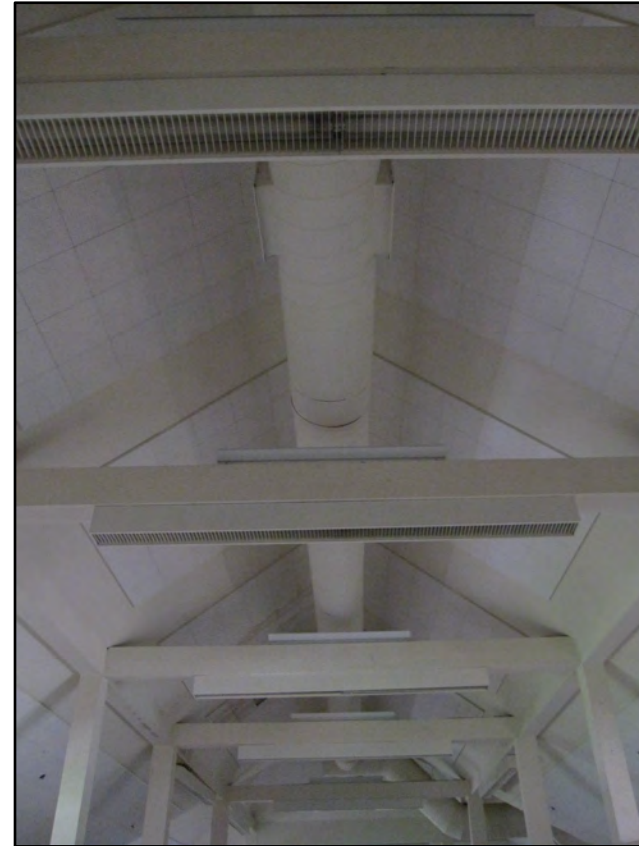
The original Queen's Truss system is exposed and in good condition in the main attic space. It has been boxed in or furred over with painted gypsum board, likely for fire protection. The ceiling of the attic originally consisted of exposed rafters, but currently the ceiling has acoustical tile. These tiles have been damaged in many places and also they exhibit water stains from areas of water infiltration from the roof above. Many dormers also exhibit damage from water infiltration where exterior flashing has failed or where window openings do not close properly. Water has also damaged some areas of the roof in the wings; likely the result of many years of neglect with regard to roof maintenance.

Above: The Queen's Truss system where it meets the apex of the roof.

Left: A view of the building's Queen's Truss system as it meets the attic floor.

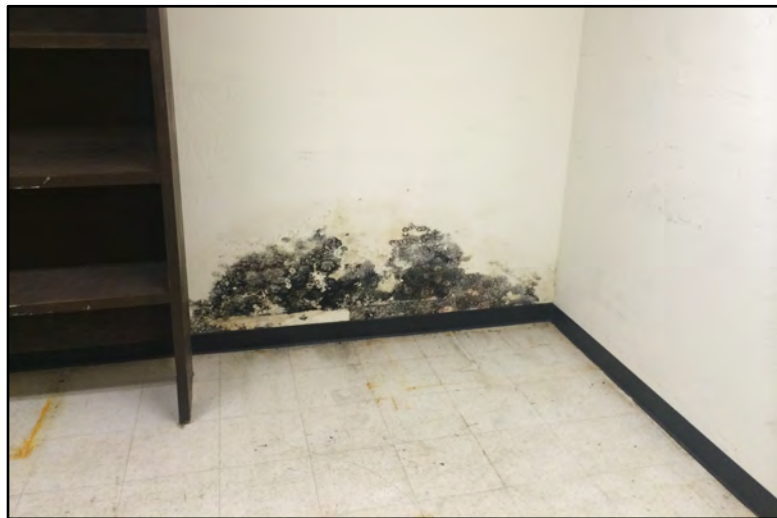
Generally, the interior basement spaces are in poor condition. The two main stairs leading to the basement are in their original location and the south stair retains some original wall fabric. There are areas of considerable mold basement, indicating a moisture problem. There is a variety of flooring in the basement, none in good condition. The basement windows are boarded from both the exterior and the interior and their conditions could not be observed.

Above: The basement stair at the south side of the building retains some original wood wainscoting and a railing.
