### REUSE ANALYSIS POST EXCHANGE AND COMMISSARY

### TECHNICAL MEMORANDUM

28 DECEMBER 2001

subject	Reuse Analysis Memoranda		
contract/task no.	PT-2000-010/TX015142		
project no.	14017.00		
project name	Reuse Analysis of PX and Commissary		
from	Sasaki Associates Inc.		
to	The Presidio Trust		
date	28 December 2001

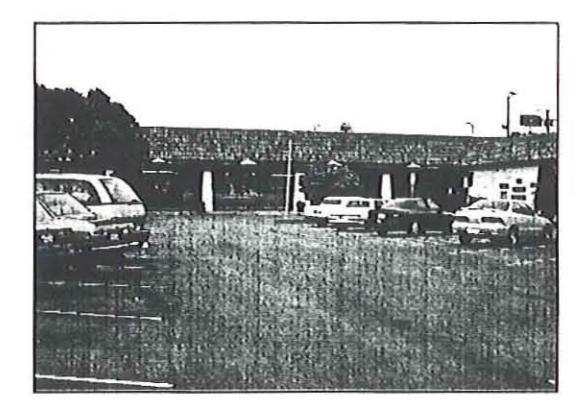
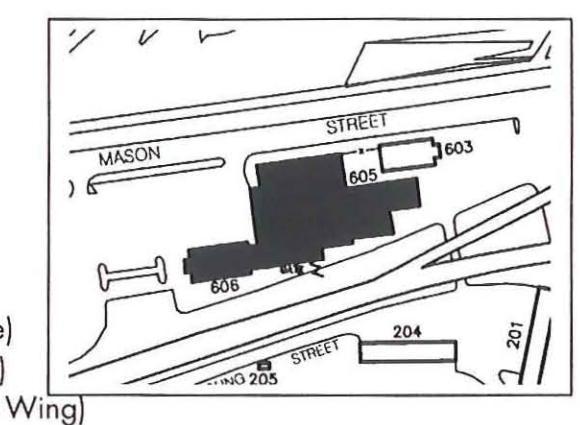
Condition: Good

These buildings are not historic, nor do they contribute to the historic character of Crissy Field, and thus are probably good candidates for removal. In some ways their character actually detracts from the visual architectural quality at Crissy Field.

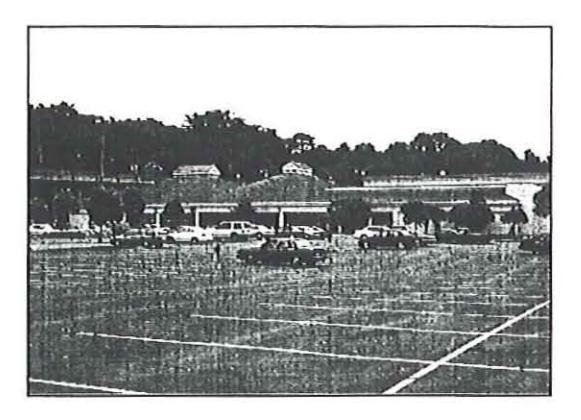
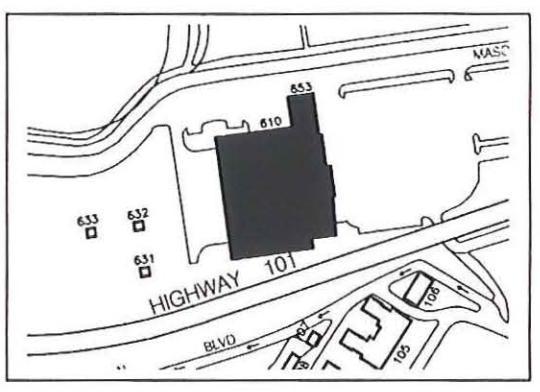
Condition: Good

These buildings are not historic, nor do they contribute to the historic character of Crissy Field, and thus are probably good candidates for removal. In some ways their character actually detracts from the visual quality of the surrounding buildings. They could be redesigned to some extent to fit into the architectural vernacular found at Crissy Field.
